**UNIVERSITÀ  
DEGLI STUDI  
DI BRESCIA**

**Architectural Restoration and conservation  
TECHNICAL REPORT**

# 1. Irma

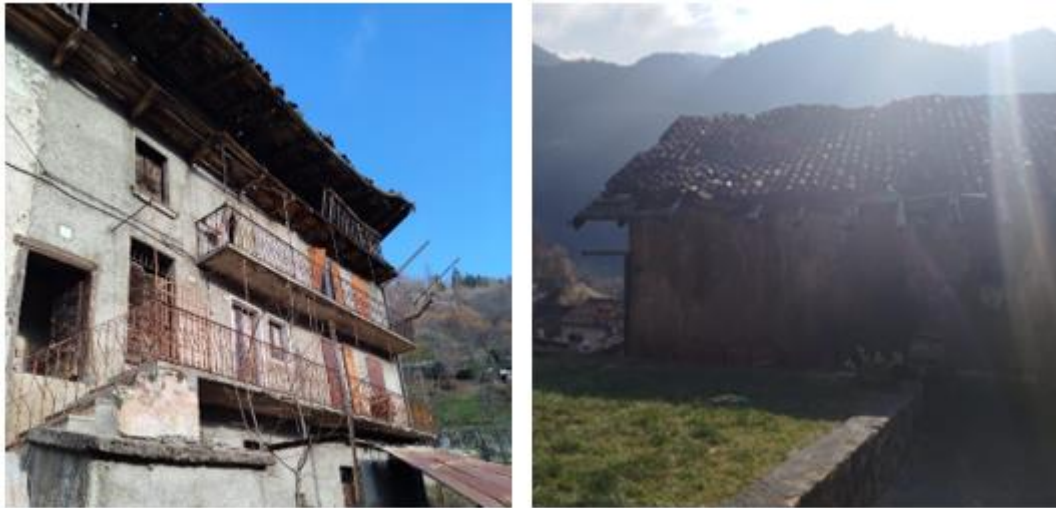
Figure 4 Facade and Back of Casa Renica

The first building analyzed during the field trip was **Casa Renica** (figure 4), a historic structure located in Vicolo Tre Archi in Irma. The site was constructed with traditional mountain building methods and likely dates back to the 17th or 18th century, the different materials used for balconies (wood and reinforced concrete) show that the building has undergone various transformations over the years. [2] Today, the building shows severe signs of decay and neglect. The wooden balconies are in such poor condition that they are losing pieces, while the reinforced concrete balconies added during the 20th century are thin and deteriorating. Furthermore, the roof structure is significantly aged and already exhibits a partially collapsed section. Because of these significant structural concerns, the entire complex needs to be restudied and redesigned to ensure its future safety and stability

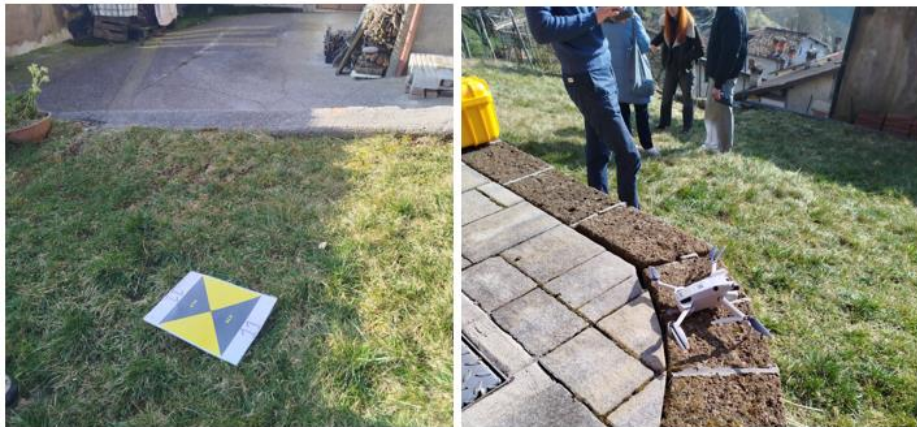
Figure 5 on the left, targets used for GPS positioning, on the right, drone

The initial phase of the survey involved the combined use of GPS instrumentation and a drone. Several ground control targets were placed on the ground and measured using GPS in order to obtain precise reference coordinates. These targets were clearly visible in the drone images and allowed the aerial data to be accurately georeferenced (figure 5).. This integrated approach ensured a reliable spatial framework for all subsequent survey operations. Aerial images and photogrammetric data can be also particularly useful for assessing damage, such as collapsed roof portions or deteriorated structural elements.

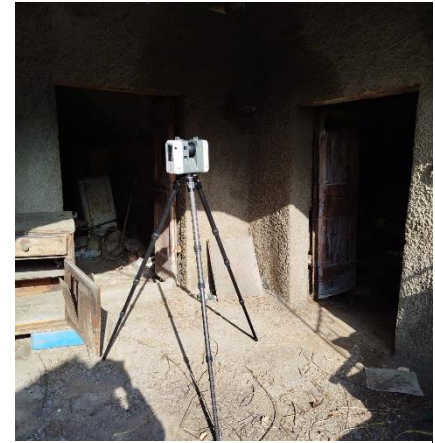
Figure 6 Laika laser scanner

Subsequently, Laika laser scanner was used to acquire detailed geometric information. This technology allows the generation of highly accurate three-dimensional point clouds by measuring distances between the instrument and the building surfaces. The result is a precise digital model of the structure, useful for documenting its current condition and identifying structural deformations or irregularities.

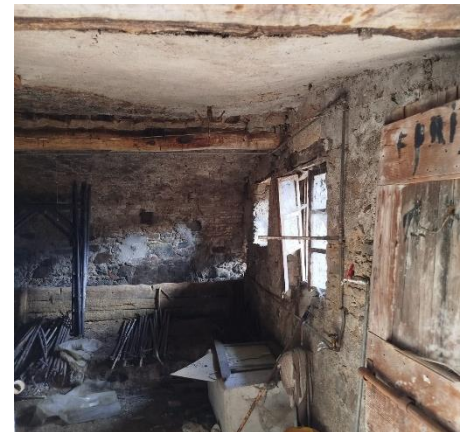
The ground floor was originally a stable for cows, and its layout still reflects this use. The floor shows a raised platform where the cows stood, with a drainage channel in front for waste. Along the wall, the original feeding area is still visible. The room also shows signs of a later intervention, with an added wooden beam providing extra structural support.

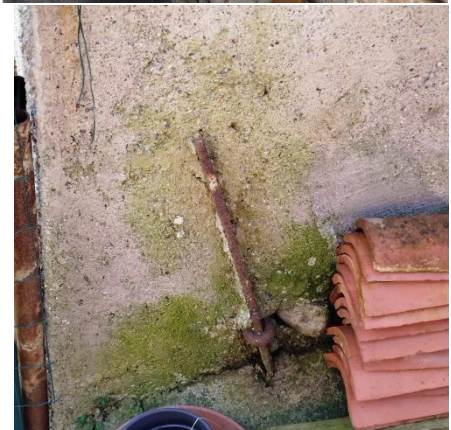
Figure 8 steel bars in the back

Behind the façade we can see a metal element sticking out from the floor, embedded in the concrete structure. It consists of two rods: one smooth and one rusted, with the latter partially wrapped around the former, as if to create an anchoring or reinforcing point. The assembly clearly indicates a subsequent intervention compared to the original construction. The presence of oxidation and the arrangement of the rods suggest that they were intended to reinforce the structure.

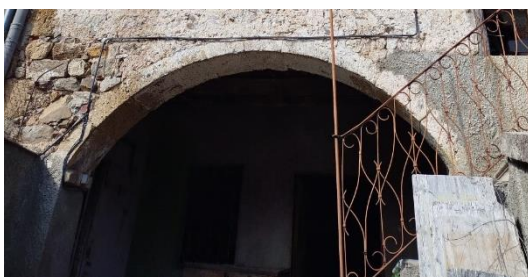
Figure 9 Arch Casa Renica

The image shows a stone archway made of local quarry stone. The warm, orange-toned stones forming the arch are a clear example of traditional local craftsmanship. An interesting observation is that the archway is partially obscured by the staircase. This suggests that the stairs

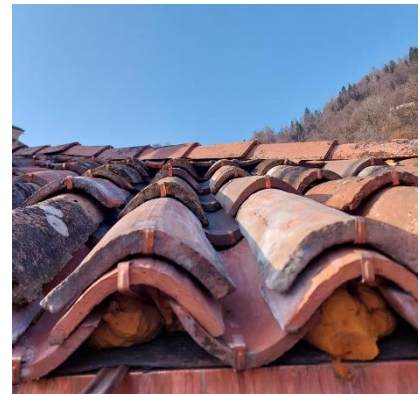
Figure 10 Copper hooks holding tiles

The original curved clay roof tiles were maintained instead of being fully replaced, following a conservation-oriented approach aimed at preserving as much existing material as possible while improving structural stability. An additional protective layer was installed beneath the tiles to enhance waterproofing performance, and they were secured using S-shaped copper hooks to ensure proper fixation and durability while maintaining the traditional roofing system.

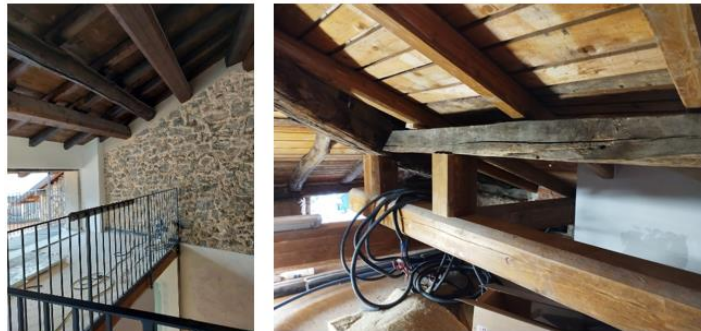
Figure 11 old and new wooden beams

After examining the roof, we gradually moved downward to observe the internal structural elements. Here, we could clearly see the integration between original beams and newly added wooden supports, designed to enhance load-bearing capacity while respecting the original construction system.

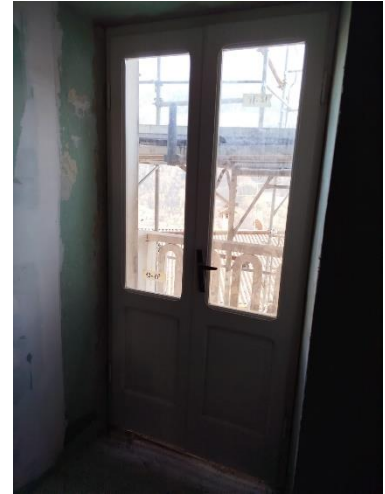
Figure 12 treated door

Continuing the visit, we reached the lower floors, where we observed restored wooden doors that had been repainted and treated. These elements showed how surface interventions can contribute to both protection and aesthetic improvement.

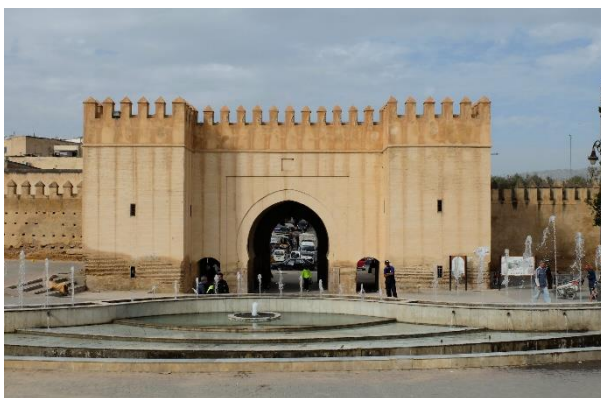
One example that represents this continuity is Bab Ftouh, one of the historic gates of the old medina. The name Bab (al-) Ftouh literally means "Gate of the Opening," but historically it has been interpreted as "Gate of Conquest" or "Gate of Victory."

Originally established in the 11th century and rebuilt in its current form around 1212 during the Almohad period, the gate has preserved its historic character despite many restorations over the centuries.

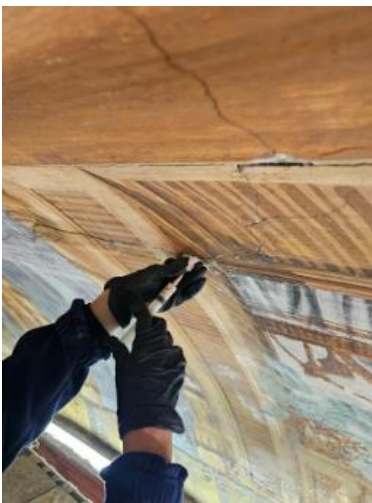
One of the main principles explained on site is that original plaster is considered an essential historical layer and, whenever possible, it is preserved rather than removed or replaced. Even when detached or damaged, it is treated as part of the building’s memory.

A key technique shown during the visit was the consolidation of plaster through injections. In cases where the plaster is no longer well attached to the masonry, a fluid mixture is inserted using syringes in order to re-establish adhesion between the support and the surface layer. This method allows intervention in a minimally invasive way, avoiding the loss of original material. It also demonstrates how restoration today relies on precise technical operations rather than complete replacement.

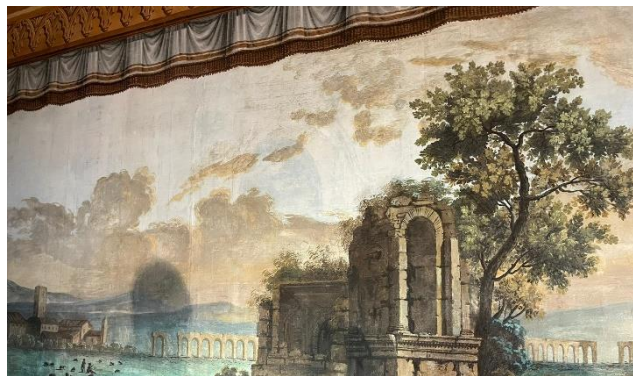
A particularly important aspect of fresco restoration that was explained during the visit concerns the treatment of losses. When large portions of decoration are missing, they are not reconstructed or repainted, in order to avoid creating a false historical image. Instead, the gaps are left neutral and clearly readable.

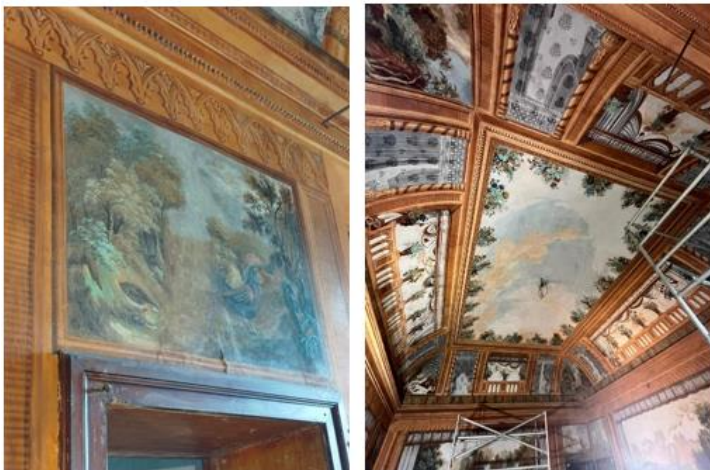
One of the most striking spaces observed was a large hall with a very high ceiling and rich decorative system. The proportions of the room, with a height well above five meters, enhance the visual impact of the frescoes and contribute to the perception of the space as both architectural and symbolic. At the four corners of the ceiling, representations of the Four Seasons are visible, forming a coherent decorative cycle that frames the room.

I was also impressed by the frescoed hall, especially the ceiling with the Four Seasons. Even after all the technical explanations, the room still looked very powerful and beautiful. It made me realize that restoration is not only a technical job, but also something that allows people to continue experiencing and appreciating these spaces today.

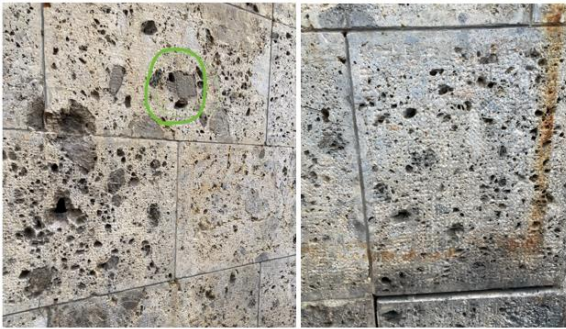
In this figure, we can observe stone slabs that were used to protect the original stone. On one slab we can see red stains caused by the oxidation of iron. These stains can be removed with cleaning, however it must be done carefully, because cleaning always could remove small parts of the stone.

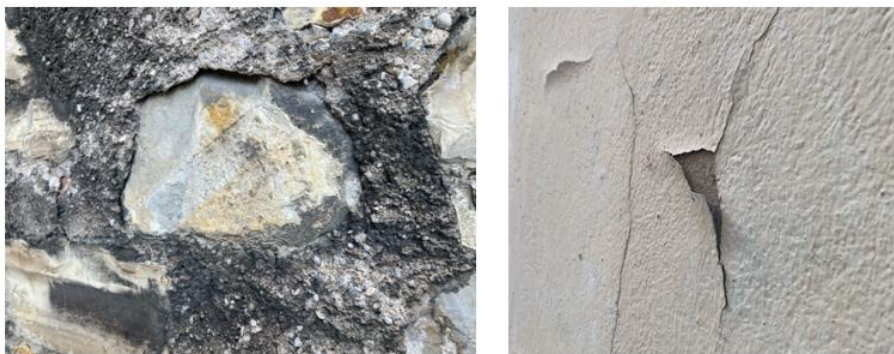
Other types of degradation are lacuna and detachment, that we could observe on several buildings. Detachment happens when part of the surface separates from the support. If that detached part falls away completely, it leaves a lacuna. These degradations are common on plaster and stone surfaces.

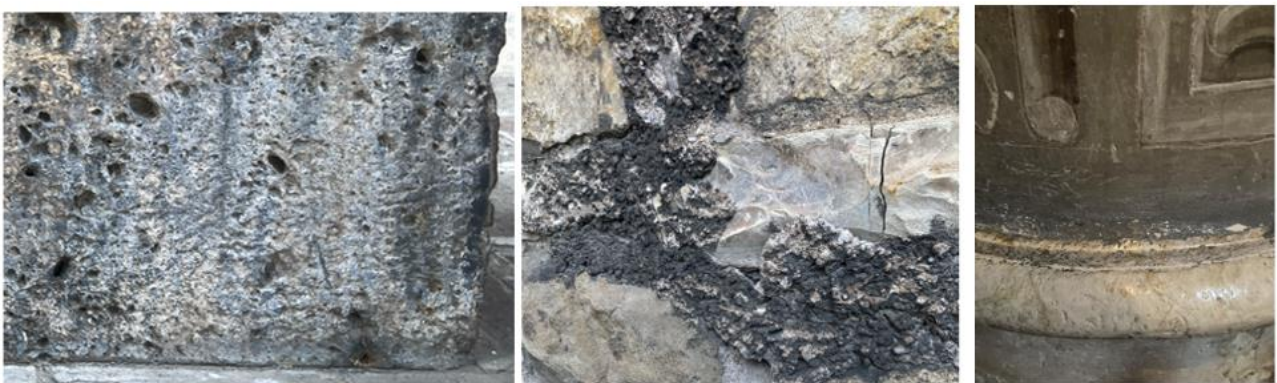
The professor also showed us crusts on stone surfaces. Black crust is usually caused by pollution and chemical reactions. In some areas the crust was also connected to dog urine because salts can contribute to the formation of effluorescence (left image). If black crust penetrates inside the stone, it can cause the loss of the original surface (central image). Dust deposits may also become crusts after many years if they are not removed (right image).

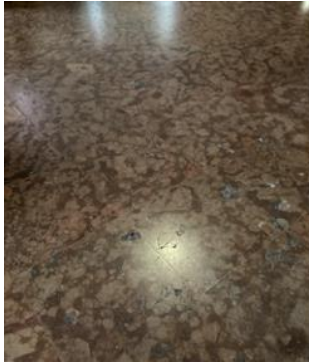
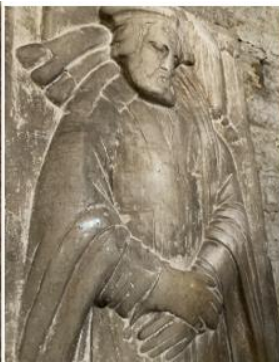
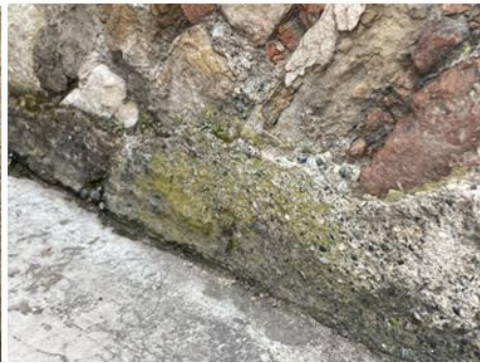
In several buildings we identified scaling and alveolization. Scaling is the detachment of thin layers from the stone surface. Alveolization, also called honeycomb decay, creates small cavities that give the stone a honeycomb appearance.

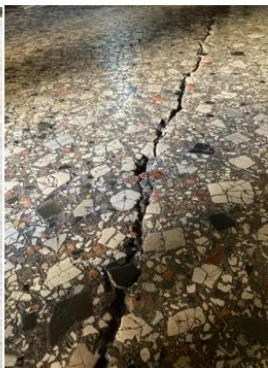
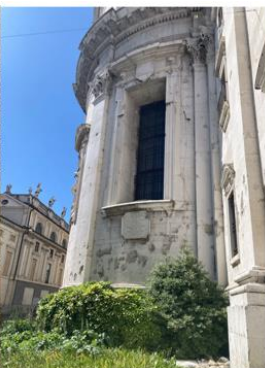
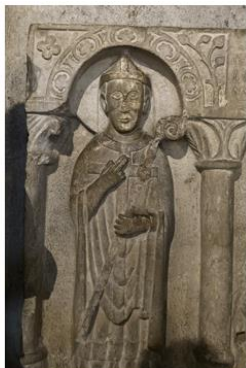
Patina was another important topic during the visit. Patina is a natural surface modification that develops over time due to ageing and environmental exposure. It acts as a protective layer, though it can take many different forms depending on the stone, the environment, and biological activity.

Patina is generally considered part of the history of the monument and should not be removed. For example, bleach can remove the patina and damage the historical value of the stone (left image, they used to clean with bleach but then they saw it caused damage).

It could be caused even by people touching statues continuously (central image).

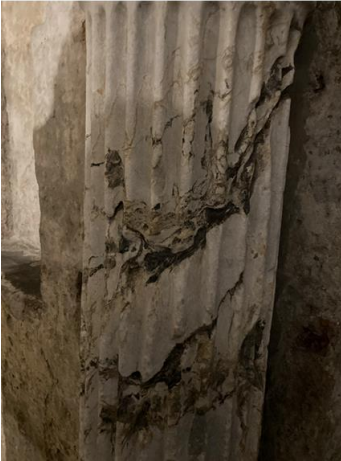
The professor pointed out some previous restoration works carried out with incompatible materials, such as concrete used to fill gaps in historic columns. Modern materials are sometimes chemically or physically incompatible with the original stone and may create new degradation instead of solving the problem. This is why restoration today always tries to use compatible materials and preserve the original structure whenever possible.

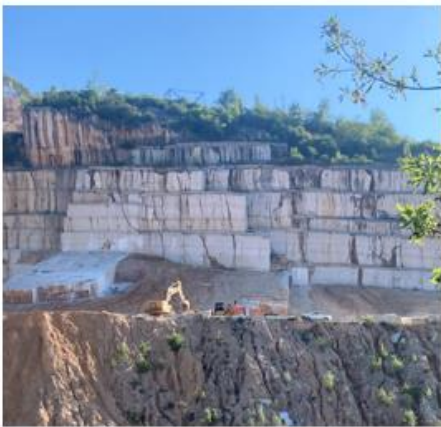
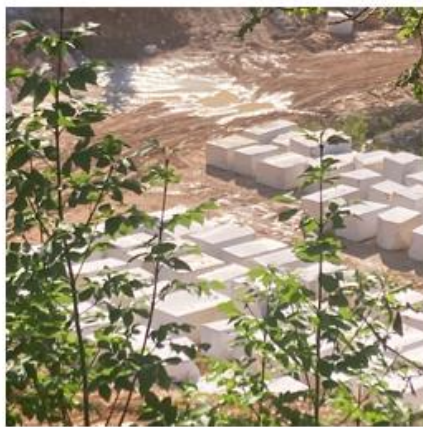
The professor explained that quarrying produces a lot of waste. Only about 25% of the extracted rock becomes commercial blocks, while the remaining 75% is waste material because it contains fractures, impurities or has the wrong dimensions. Part of this waste is not completely discarded because it can be reused to produce lime, fillers and other construction materials.

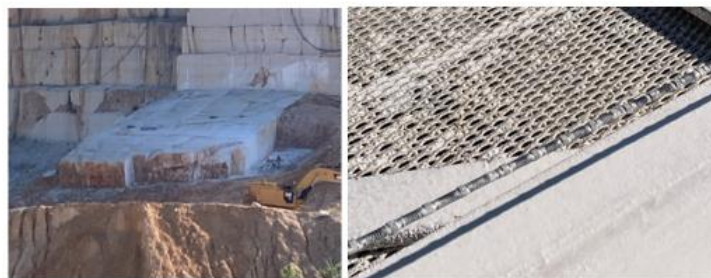
We also saw the large bedding planes of the stone. The orientation of these natural layers is very important because the blocks must be cut following the bedding planes. If the stone is cut in the wrong direction, it becomes weaker and can break more easily over time.

The extraction process starts by isolating the block from the rock mass. Today this is done mainly with a diamond wire saw. The steel wire, covered with industrial diamonds, cuts the limestone very precisely and allows large blocks to be detached with limited vibrations compared to older extraction methods.

After the extraction, the blocks are transported to the production area. Here we visited the factory where the stone is processed. The large blocks are first cut into slabs using a large frame saw (the yellow machine in the picture).

This yellow machine produces slabs with a uniform thickness that can later be used for floors, walls and cladding.

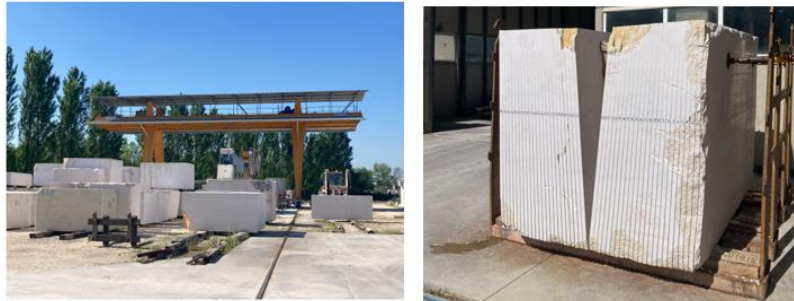
Before the slabs are finished, a resin is applied to the stone. The resin fills small pores and natural imperfections and also strengthens the slab, reducing the risk of breaking during the following processing stages.

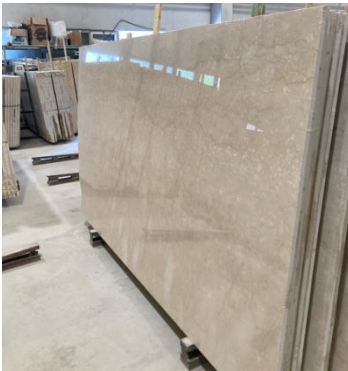
Finally, the slabs pass through polishing machines. First they are ground to obtain a flat surface, and then they are polished until they become smooth and shiny. According to the final use, the slabs can also receive additional cuts or different surface finishes.

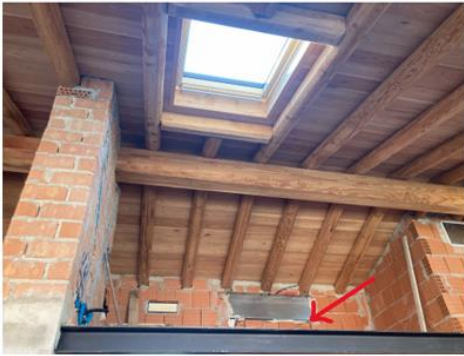
The old floor structures were replaced with new solid timber floors and they chose solid wood instead of laminated wood to keep a more traditional appearance. The intervention also avoided the use of reinforced concrete whenever possible, using steel beams to improve the structure while respecting the historic building.

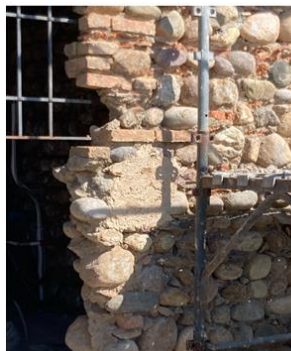
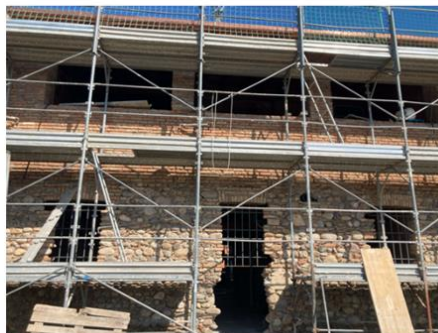
Outside, we observed that the lower part of the walls was the original masonry, while the upper part had been raised using bricks to increase the height of the building (right image). At the end of the works the exterior will be covered with natural hydraulic lime plaster, a material that is more compatible with historic masonry because it allows the walls to breathe and reduces moisture problems (left image).

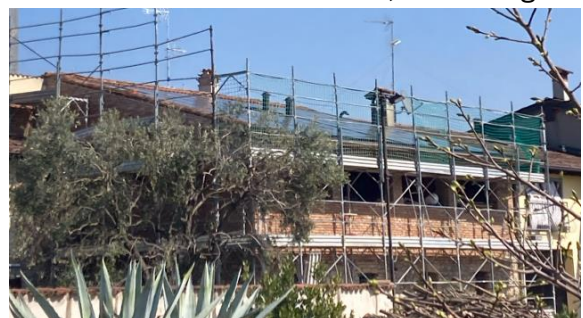
The upper part of the building was originally the hayloft, recognizable by its large rectangular openings used in the past for ventilation. We also observed the roof details, including the traditional coppi tiles, the wooden eaves and the chimney used to release smoke from the stove. The building will also have photovoltaic panels, making it a low-impact and energy-efficient house while preserving its historical appearance.

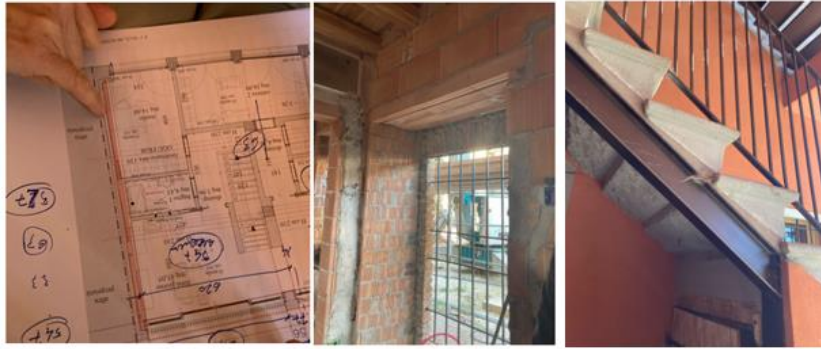
Looking at the front of the building, we noticed that there was a side of the building directly attached to another property, so the masonry wall was insulated from the inside. In this situation it was not possible to intervene from the outside.

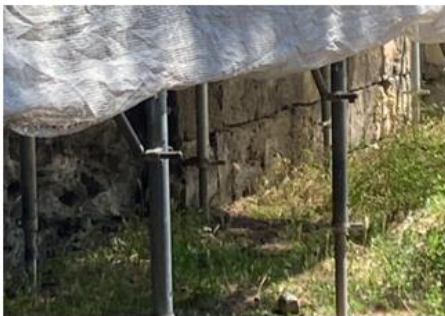
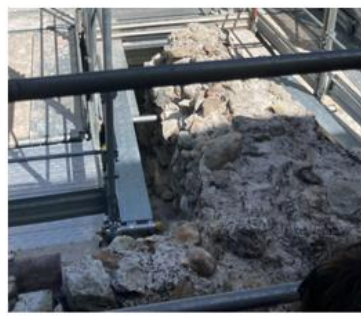
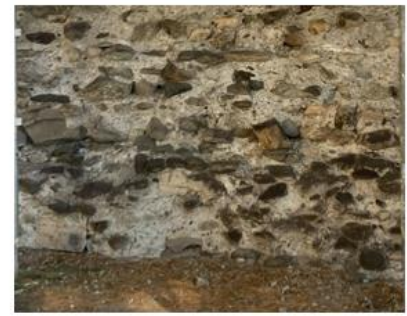
In the morning, we started by exploring the Roman city walls. These walls show a typical Roman construction system with a double structure: an external layer originally made of large, regular blocks of travertine or natural conglomerate (left image), and an internal core made of *opus caementicium*, a type of Roman concrete mixed with river stones and aggregates. Locally in Aosta, this internal core material is traditionally called *sacco* (central image, picture taken from above).

On the top section of the wall we could see that the internal structural buttresses are directed toward the inside of the city, while the flat stone face looks outside.

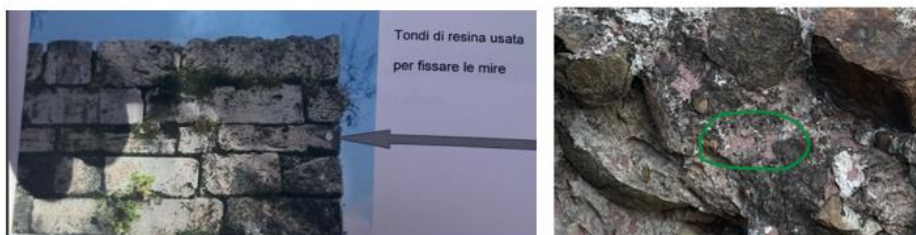
- Monitoring the walls by using small resin disks to hold mirrors for structural control (left image)
- Putting a special liquid (biocide) on the walls to kill plant roots without hurting the stones.
- Cleaning the surface without water by using a dry system with special pink sand (right image)

No water washing was allowed, as water can cause dangerous phenomena due to frost-thaw or wet-dry cycles, where freezing water expands inside the open pores of the stone and causes a loss of cohesion, leading to cracking and detachment.

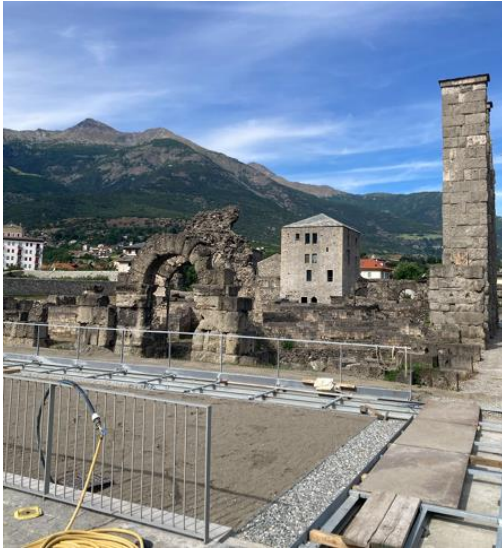
Later, we visited the Roman Theater of Aosta. In Roman urban planning, theaters were usually built outside the city walls, but the theater of Aosta is a special exception because it was built directly inside the fortified perimeter. The city walls themselves were heavily fortified and connected to numerous defensive towers located at regular distances. The theater is still partially preserved, and its most impressive feature is a large, 22-meter-high façade wall with regular openings.

The building suffers from typical degradation problems, and water represents the main threat to the structure because of the low temperatures during winter. The frost-thaw cycles cause the water inside the stone pores to freeze and expand, which accelerates the damage to the masonry.

The stratification of the wall shows different historical phases, including past restoration interventions where protective, sacrificial layers of mortar and stone were applied to absorb weather damage and protect the original Roman materials underneath. Today, the site includes new work like the surrounding pavement and modern railings; however, these additions are often criticized because the design of the railings is visually invasive and alters the aesthetic value of the ancient monument.

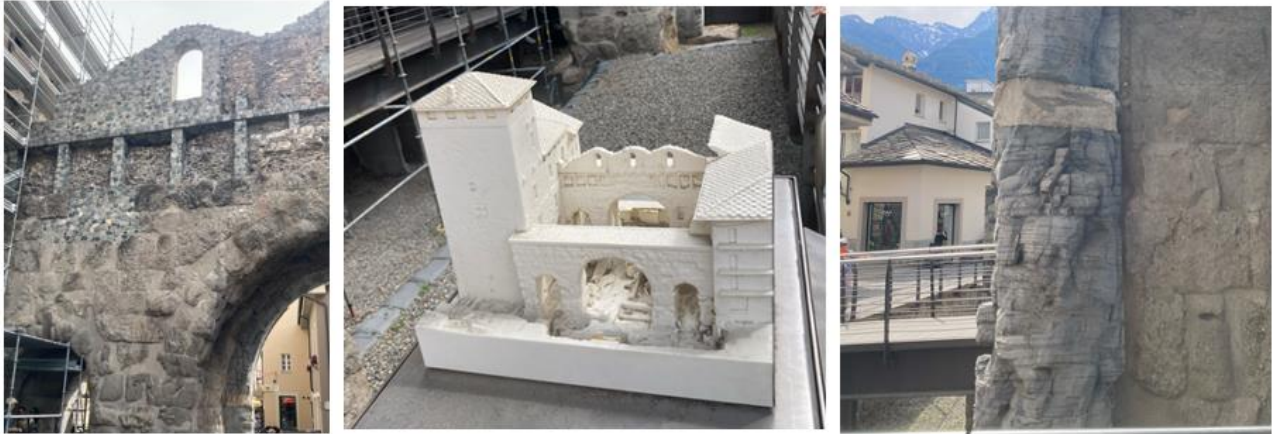
The structure features a very fine finishing layer of original Roman plaster (central image); one of the most interesting aspects was the presence of ancient repair works for example in the right image, it is possible to see that in origin there was an arch but since a main stone pillar had moved, shifting the weight of the arch above, old restorers solved this by adding a supporting integration wall.

These differences are intentionally visible, perfectly matching the principles later written in the Venice Charter of 1964, since the original wall uses large stone blocks while the restoration uses smaller stones with a different surface texture to avoid creating a historical fake.

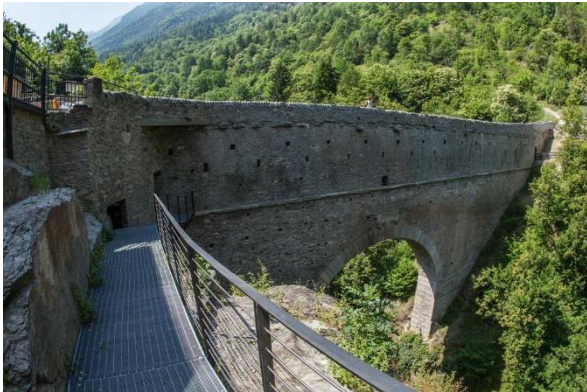
In the afternoon, we visited the Pont-d'Ael, a Roman aqueduct bridge built in 3 B.C. over a deep valley. It is an amazing example of Roman engineering with two levels: an upper channel to carry water and a lower covered tunnel for people walking. On the upper part, archaeologists found the impression of a nailed boot left in the ancient mortar by a Roman worker. Outside the bridge, excavations also

To build the bridge, Roman engineers cut and shaped the bare rock of the mountain to create a strong foundation. The entrances to the lower tunnel have rounded stone arches with small square holes in the floor, showing where wooden doors were originally attached.

engineers explained that this clever system made the bridge much lighter and more flexible against earthquakes without losing its strength. They also found an original piece of a wooden beam inside a wall, and a Carbon-14 test proved it was part of the original Roman scaffolding.
