# REPORT

# ARCHITECTURAL RESTORATION AND CONSERVATION

LECTURER: Prof.ssa Barbara Scala

STUDENT: Philipp Schönfeld

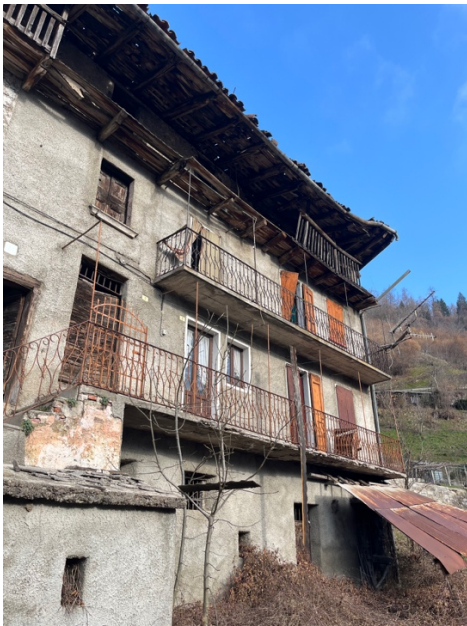
House Renica, historically referred to as the House of “Galli” (Italian for “chicken”), dates back to the 16th century. The building has a ground area of approximately 180 m<sup>2</sup> and consists of three storeys, each measuring roughly 10 × 18 meters. Constructed using traditional rural building techniques typical of the region, the structure represents an example of the local vernacular architecture.

Although the building appears as a single structure from the exterior, it actually consists of four interconnected building units. Each of these units includes three usable floors and a partially habitable attic. The complex is located along the narrow alleyway Vicolo Tre Archi, which provides access to the property through a vaulted passage leading to a small courtyard.

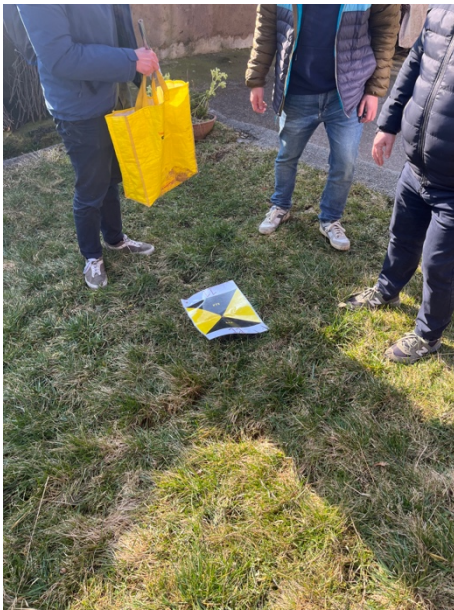
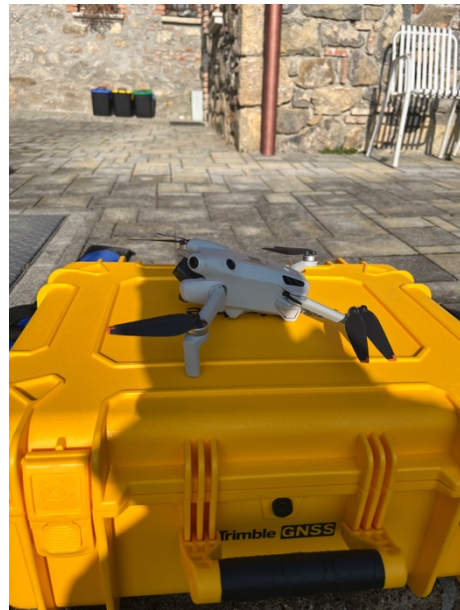
Before the drone flight, ground control points (GCPs) were distributed around the building. These targets were used to record the precise geodetic position of reference points. The objective was to capture the building in a georeferenced manner, enabling a geologically and spatially accurate model. Proper placement of the control points was crucial: they were carefully distributed both in the planar dimension ( $x$ - $y$  axis) and at different height levels ( $z$ -axis). This three-dimensional distribution ensured improved accuracy and stability of the resulting digital model.

The control points served multiple purposes:

- Georeferencing the building within a coordinate system
- Ensuring accurate scaling
- Allowing correct spatial positioning of the later generated point cloud
- Providing a standardized format that could be processed and shared among all participants using compatible geomatics software

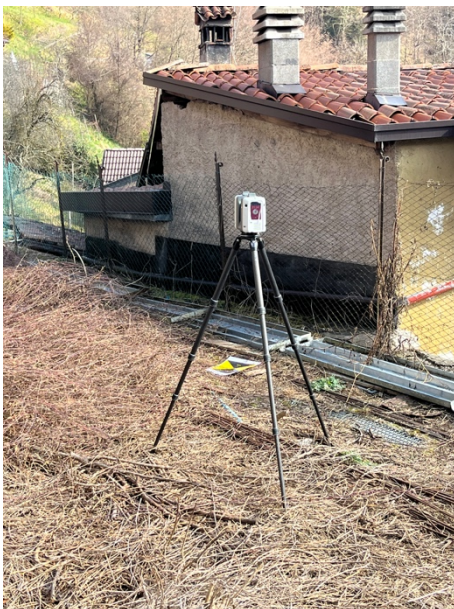
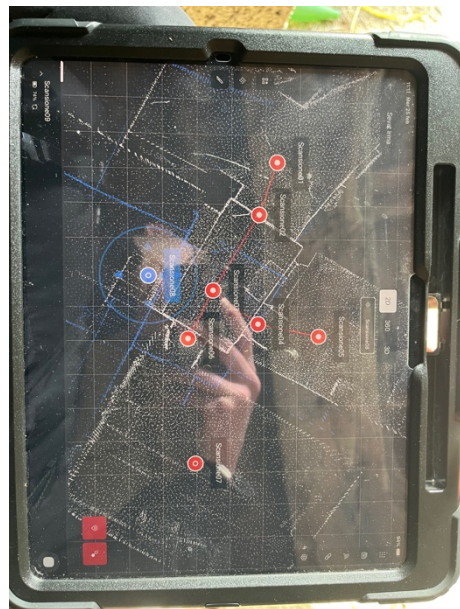
The Leica laser scanner was positioned at multiple locations around and, where safely possible, within the building. The purpose of using several scan stations was to minimize blind spots and ensure comprehensive spatial coverage. From each position, the scanner recorded the surrounding environment by emitting laser pulses and measuring their return time. The detected surfaces were translated into a dense set of spatial data points, generating a three-dimensional point cloud.

The scanner integrates cameras that detect and record the surrounding area, supporting spatial orientation and scan alignment. However, the resulting data is typically monochromatic (black and white), as the primary focus lies on geometric accuracy rather than photorealistic texture.

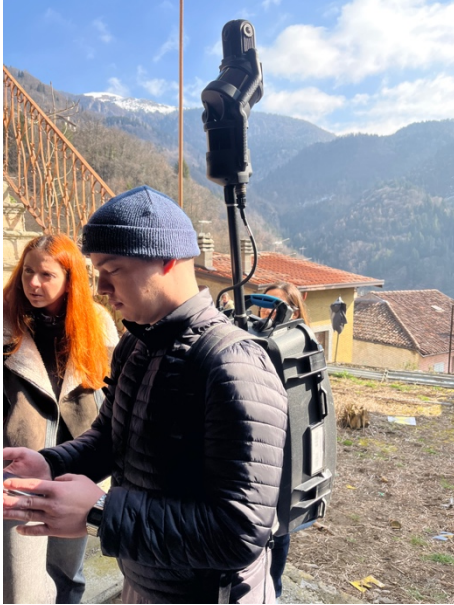
The device is integrated into a backpack system and is operated while walking along a predefined scanning route. The user controls and monitors the scanning process via a smartphone interface. The system is equipped with multiple cameras and sensors that capture a 360-degree representation of the surrounding environment during movement.

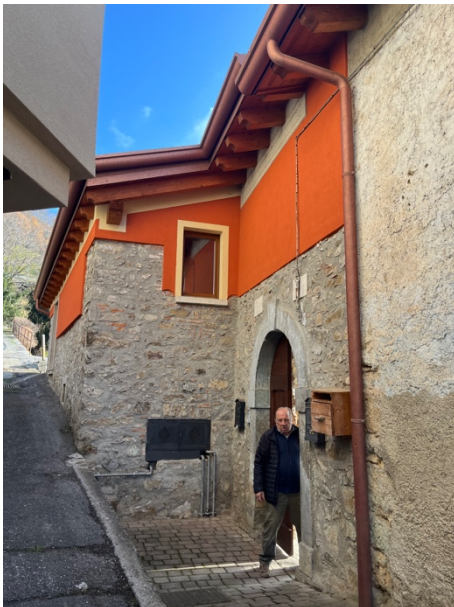
During the village walk, one building with a partially orange-rendered façade was examined. The façade treatment appeared unusual, as the colored plaster covered only half of the exterior surface. This configuration was not structurally motivated but rather driven by aesthetic considerations.

The example led to a broader discussion on external insulation systems. In mountain regions such as Irma, external insulation can present certain disadvantages. When insulation is applied to the exterior, it often requires the façade surface to be significantly modified or re-rendered, potentially affecting the material authenticity of historic masonry.

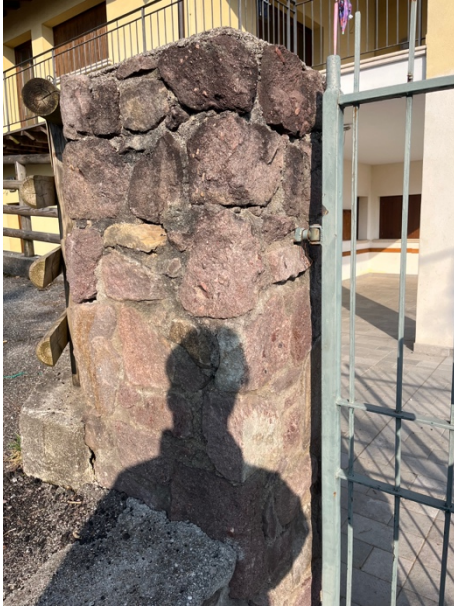
Another example related to stone masonry construction. Stones in load-bearing walls should ideally be laid horizontally. This orientation ensures that erosion does not occur parallel to natural stone layers, which would accelerate material degradation. Proper bedding direction enhances durability and structural stability.

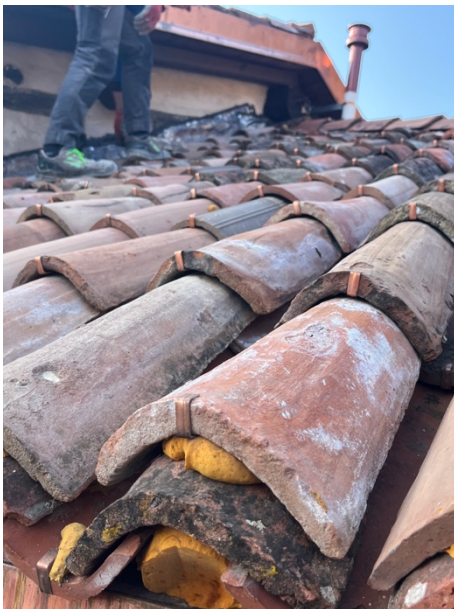
One example discussed was the stabilization of roof tiles. In order to prevent sliding or displacement—particularly under wind exposure—copper clips can be installed to secure the tiles. This solution allows the preservation of the existing roofing material while improving safety and durability without altering the overall appearance.

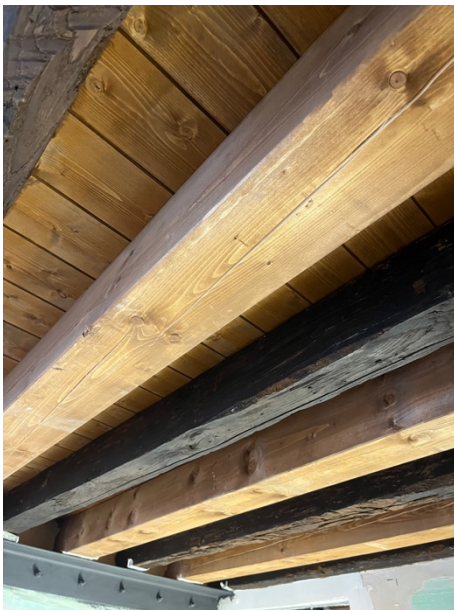
The condition of timber beams was also addressed. Where wooden structural elements are severely deteriorated, full replacement may be unavoidable. However, if the damage is partial and structural integrity can still be maintained, reinforcement is preferred over substitution.

- Adding supplementary timber beams
- Integrating supportive elements adjacent to the original structure
- Localized repair instead of complete removal

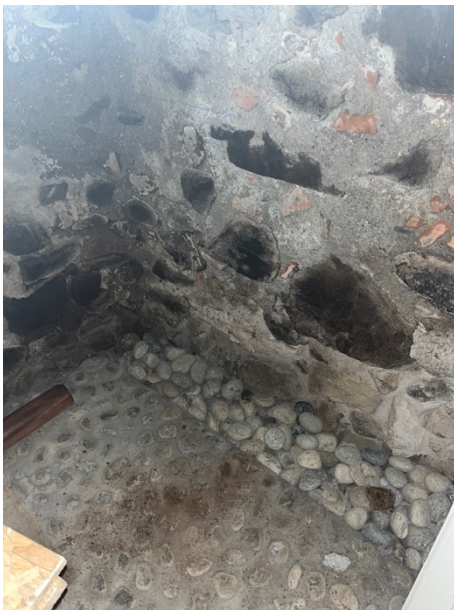
A significant problem identified in House Corsini concerns high moisture levels in the basement areas. Persistent humidity poses risks to structural stability and long-term material preservation.

To mitigate this issue, the installation of so-called “igloo” systems beneath the floor slab was discussed. These modular plastic dome structures create a ventilated cavity between the ground and the interior floor. By allowing air circulation underneath the floor, capillary rising damp can be reduced and moisture levels better controlled.

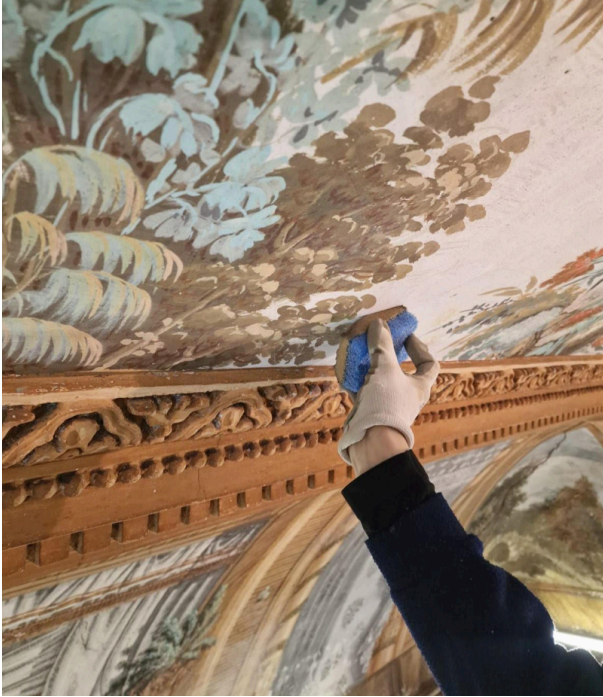
The cleaning process in this room was therefore performed entirely with dry methods. The procedure started with the use of a soft dry brush to remove loose dust from the surface. Afterwards, conservators used a bread sponge, a traditional restoration tool made from the soft interior of bread. The porous structure of the bread absorbs dirt particles without damaging the paint layer. This method is frequently used in conservation because it is gentle and non-invasive.

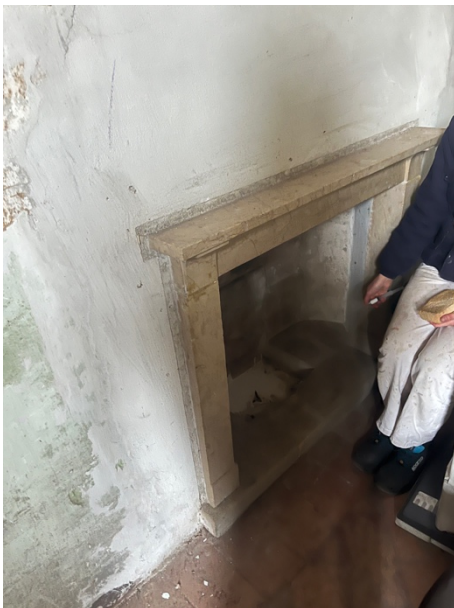
The room also contains a fireplace with significant cracks in the plaster. To stabilise the structure, mortar was injected from both sides of the wall. This technique helps strengthen the plaster layer and protects approximately 1–2 cm of the original plaster surface. The work is typically carried out from the bottom upwards, allowing the injected material to properly fill the cracks and cavities. As a result of the intervention, some white traces of mortar remain visible around the fireplace.

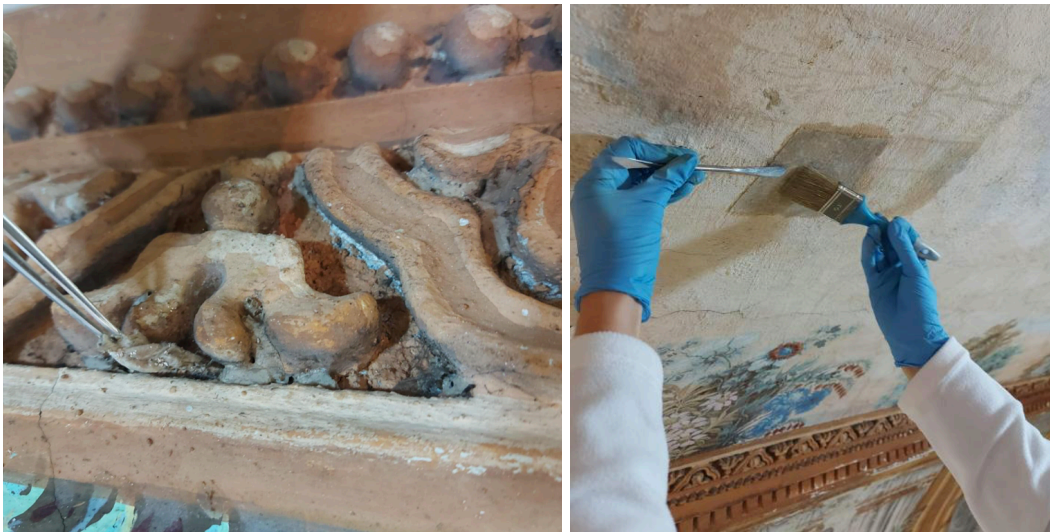
In some areas of the paintings the plaster had detached or swollen. To stabilise these sections, conservators used a syringe to inject consolidating liquids behind the plaster layer. The syringe is often used together with small pieces of cotton, which help distribute the liquid evenly and control the amount applied.

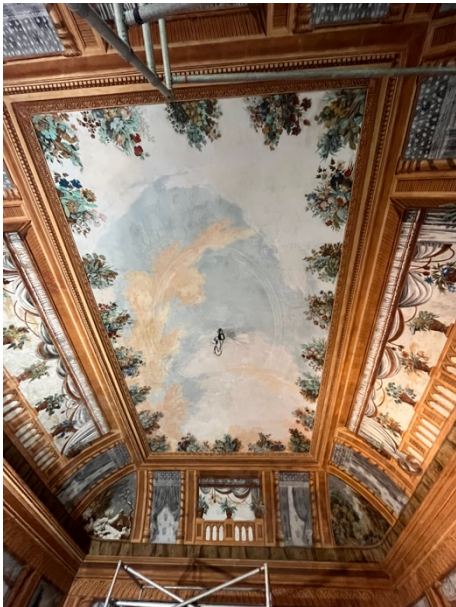
The wall paintings in the room consist of two different pictorial layers. The original decorative scheme was executed as a fresco, painted directly onto fresh plaster. At a later stage, this fresco was partially covered by a secco painting, in which pigments were applied to dry plaster. Although the upper dry painting forms the visible surface today, the outlines of the underlying fresco are still partially visible in some areas.

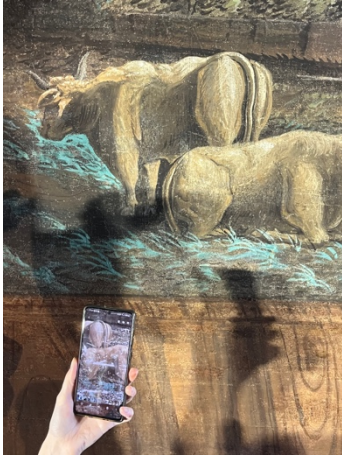
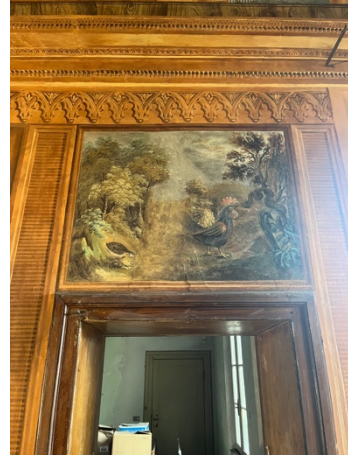
If parts of the wall paintings were missing, restorers applied retouching techniques using watercolours. The original paintings in the room were created using tempera painting (*tempera all'uovo*), which uses egg as a binding medium. Watercolour retouching is used only on damaged areas and remains visually distinguishable from the original painting, which follows established conservation principles.

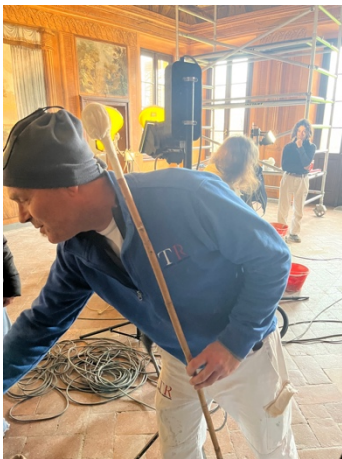
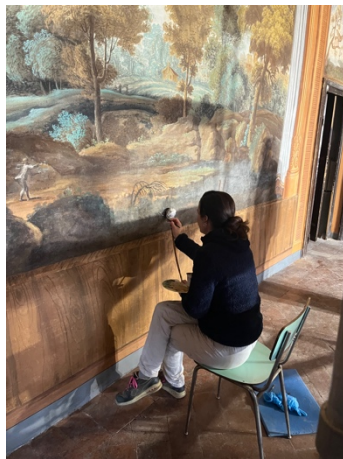
To assist in delicate painting work, conservators sometimes use a support stick wrapped with cloth at one end. This tool allows the restorer to stabilise their arm while working, preventing accidental contact with the painted surface and enabling more precise brushwork.

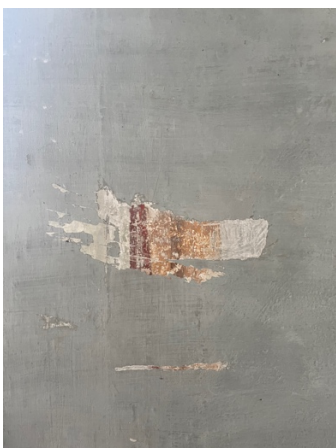
In order to investigate these underlying frescoes, restorers carefully removed small sections of the upper paint layer using a scalpel. The openings are typically made in small rectangular test areas, allowing conservators to analyse the presence and condition of the original fresco.

Such stratigraphic investigations reveal that multiple layers of painting were often applied over time, reflecting changes in use, aesthetic preferences, or interior decoration. The discovery of these layers provides valuable information about the historical development of the building.

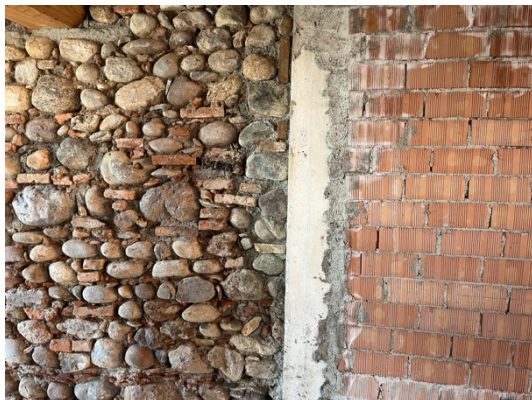
In the next picture, the wall on the left is the original historic wall that is intended to be preserved, while the wall on the right is the new masonry wall.

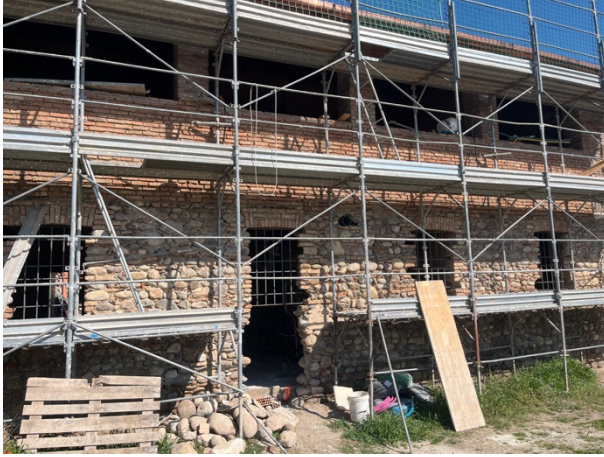
The next picture shows the south façade of the house from the outside. The lower part still consists of the original masonry, while the upper part is made of lighter new masonry. However, this upper section was not constructed with new industrial bricks, but with reused and consolidated bricks. Roof tiles were also incorporated into the wall, which further emphasizes the reuse of traditional materials and elements.

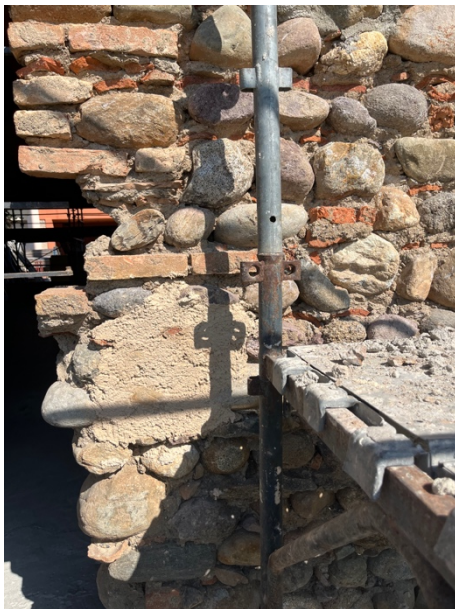
The exterior surface receives a hydraulic-lime finish, shown in the next picture. This is a traditional type of finishing that is particularly suitable for historic masonry because it remains breathable and compatible with the old structure. In this project, the finish is intentionally not fully opaque. The masonry structure underneath should still remain visible. This idea is described by the expression “vedo / non vedo” – “I see / I do not see.” It means that the surface treatment should not completely cover the wall, but instead allow the texture and structure beneath to remain partly visible.

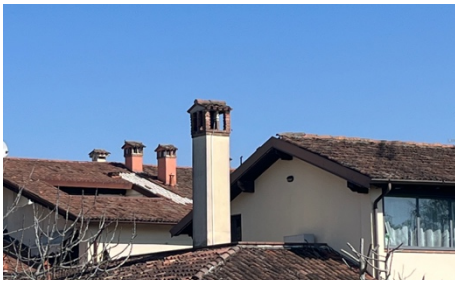
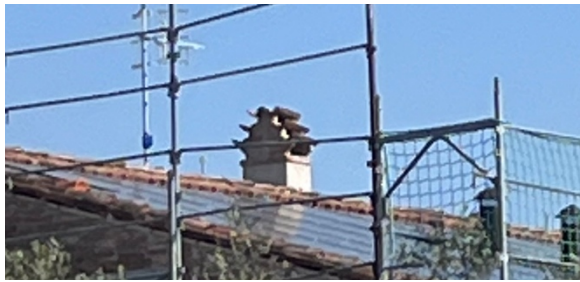
The following picture compares the old and the new chimney. The new chimney is significantly taller and has larger openings at the top, where the smoke escapes. These large openings make it easier for rainwater to enter. The old chimney, by contrast, has a more refined shape. It is formed with concave roof tiles and has a more pointed design, which offers less surface for rain penetration and allows water to drain away more easily. In addition, the old chimney appears architecturally more elegant. This comparison shows that traditional construction often solved practical problems in a more integrated and carefully designed way.

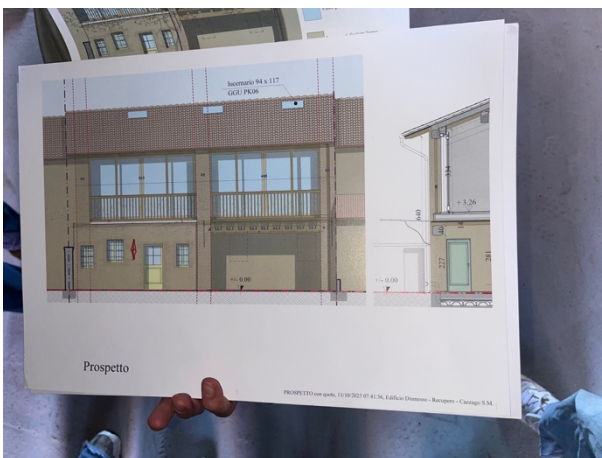
In the second part of the visit, we were shown the main renovation measures inside the building. New window glazing has been installed, and a balcony was added on the first floor. The opening of the main entrance was enlarged from 180 cm to 205 cm.

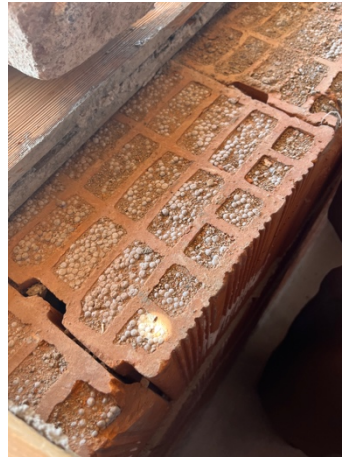
On the east side, a new wall was built for insulation. For this purpose, special bricks with insulating material integrated into their cavities were used.

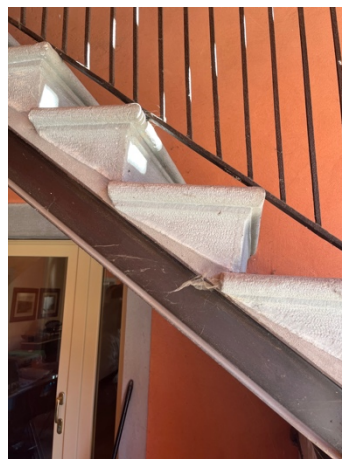
The staircase from the ground floor to the first floor is made of stone. Each tread consists of an individual stone element anchored into the walls, while the space between the treads is only constructively closed.

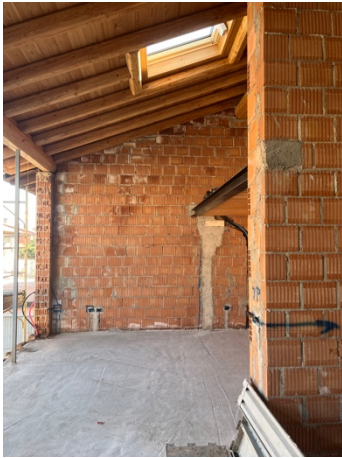
Originally, the first floor had no internal subdivision. All masonry partition walls were inserted only later during the renovation process. This new room organisation also made it possible to install a heating system. In addition, a wooden staircase was added on the first floor to connect it to the second floor.

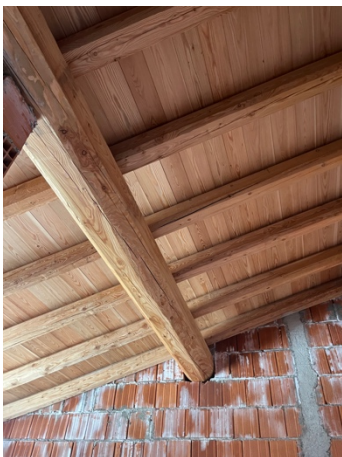
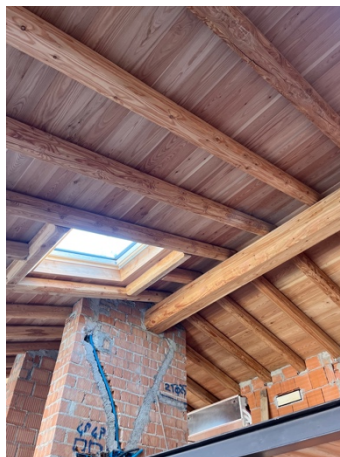
The beams used in the project correspond to the traditional “uso Fiume” type, which is typical for rural buildings. These beams are made from a tree trunk and worked into a regularised form while still preserving much of the natural character of the wood. This gives them a traditional appearance and makes them particularly suitable for historic rural architecture.

Two other common traditional beam types were also discussed. “Uso Trieste” follows the natural taper of the trunk more closely, so the section changes slightly from one end to the other. “Quattro fili”, by contrast, is more regular and geometric, with straighter sides and a more processed appearance. These different beam types are characteristic of traditional timber construction and contribute significantly to the historical identity of the building.

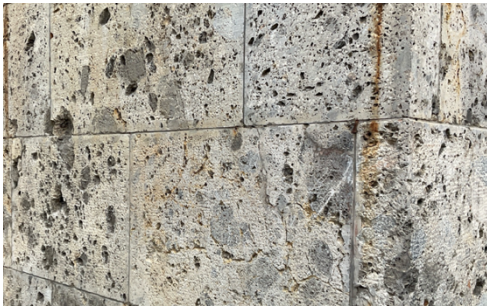
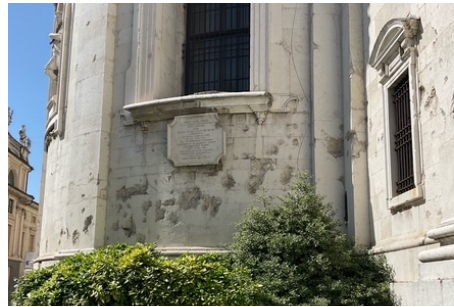
On the exterior of the church, we identified stone loss and efflorescence. Stone loss refers to the partial or complete absence of material or architectural details. It is generally caused by external factors such as weathering, mechanical impact, or long-term exposure to environmental conditions.

In the photograph on the left above, reddish staining caused by the oxidation of iron nails embedded in the stone can also be observed. When water flows over the corroded metal elements, it transports iron oxides across the stone surface, leaving red stains. If these stains need to be removed using aggressive chemical products, a very small amount of the original stone surface may also be affected or damaged.

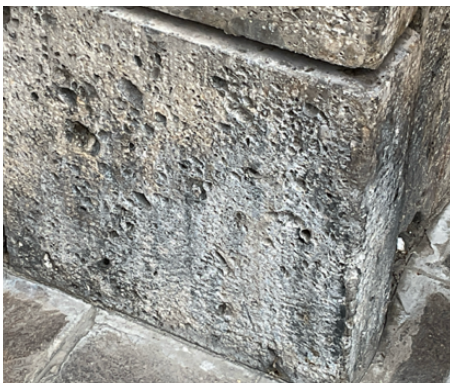
On the same wall, we also observed efflorescence, or salt deposits. This phenomenon occurs when water containing dissolved salts moves through the stone and evaporates at the surface. After the water has evaporated, the salts remain visible as a whitish deposit.

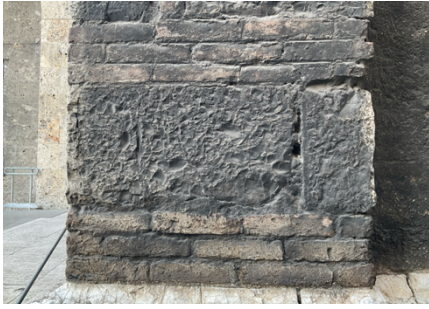
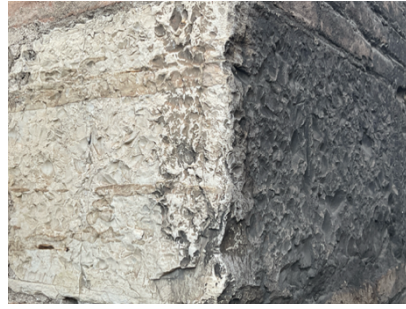
The external wall next to the entrance of the church displayed several forms of degradation, including black crust.

Black crusts are generally caused by air pollution and chemical reactions between atmospheric pollutants and the stone surface. They often develop in sheltered areas that are protected from direct rainfall, as pollutants can accumulate there over a long period of time.

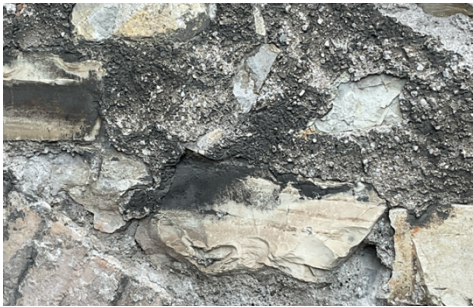
As shown in the photograph below, one section of the wall is directly exposed to sunlight and rain and therefore appears lighter, while the adjacent, more protected section appears black due to the accumulation of pollutants.

In the same photograph, surface erosion of the lighter stone on the left can also be observed. This erosion may be linked to the effects of rainwater and atmospheric pollution on the stone surface.

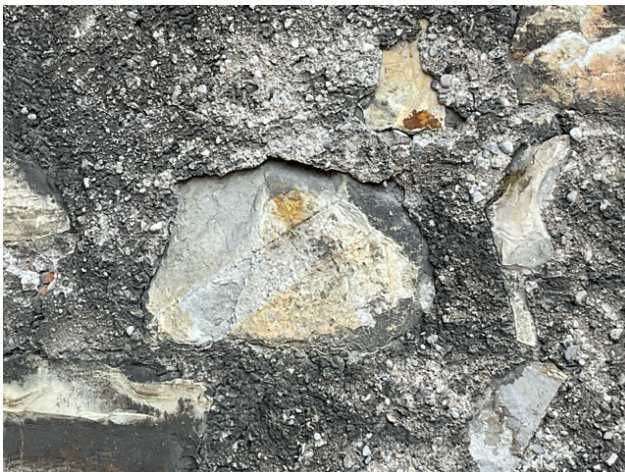
Another degradation phenomenon that we observed was the lacuna. A lacuna is a missing area, or a two-dimensional loss of material, within a surface or structure. It can be caused by long-term exposure to rainfall, mechanical damage, human intervention, or previous deterioration processes.

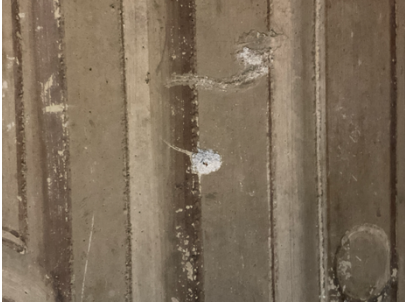
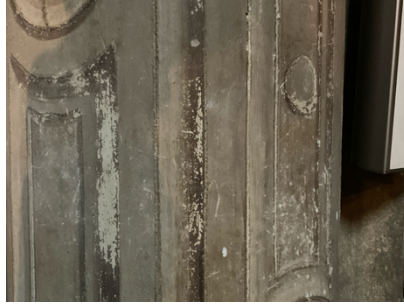
Examples of lacunae were visible both on the exterior of the church and inside the building.

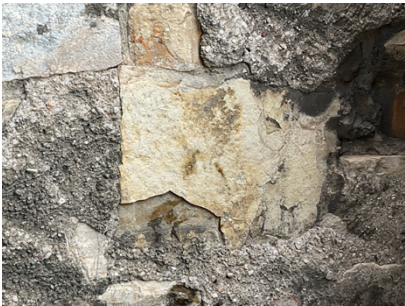
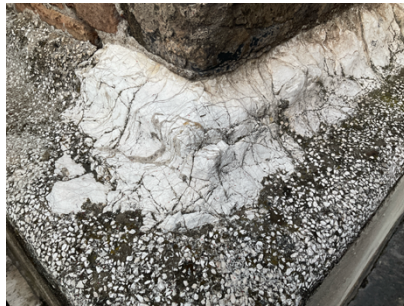
The external walls of the church also showed signs of scaling and spalling. These phenomena occur when layers or larger fragments of material detach from the original surface. They are often associated with moisture penetration, salt crystallisation, weathering, or changes in temperature.

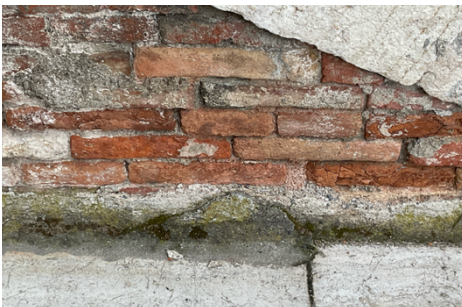
This form of degradation generally develops in areas characterised by high humidity, limited sunlight, and the presence of stagnant water. In addition to altering the appearance of the stone, biological growth can contribute to its chemical and physical deterioration over time.

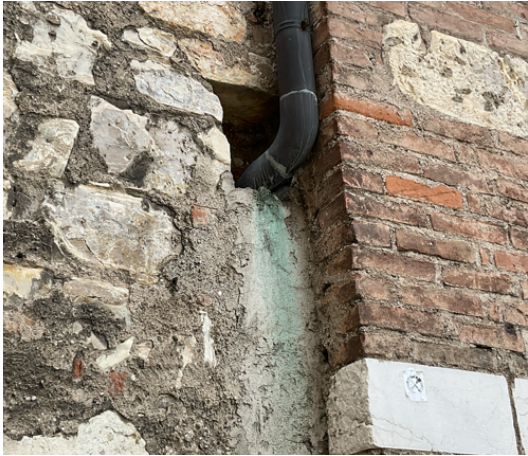
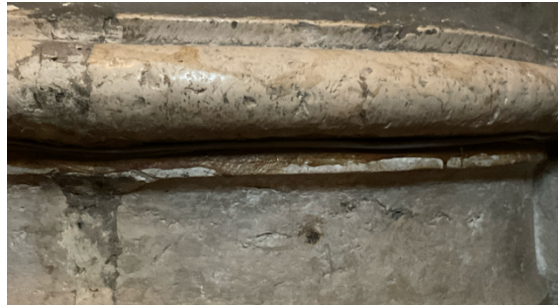
The final phenomenon observed on the exterior of the church was staining. In this case, the staining was caused by water leaking from a copper pipe. As the water came into contact with the copper, it transported corrosion products onto the wall, producing the characteristic green colour visible on the stone surface.

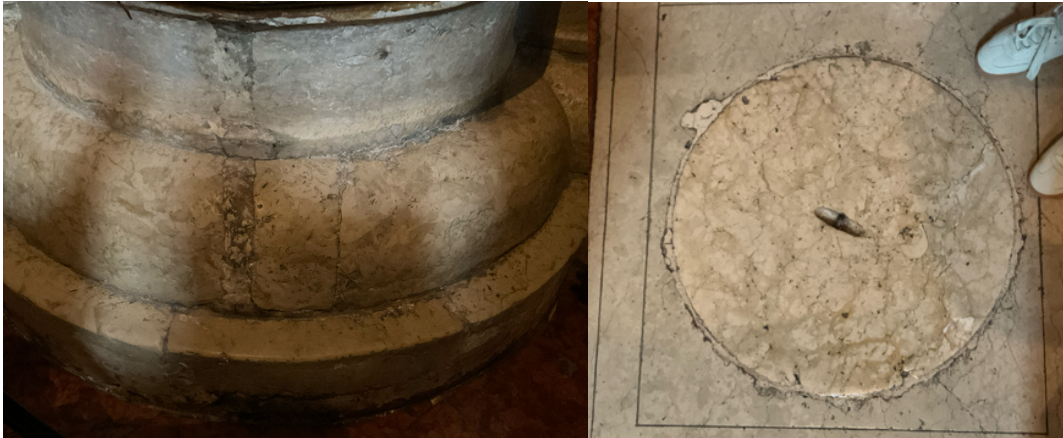
The following photographs show the presence of patina. Patina is a thin layer that naturally develops on a surface as a result of aging and interactions between the stone, air, moisture, and pollutants.

Unlike many other degradation phenomena, patina may have a protective effect, as it can form a relatively smooth and stable layer on the surface of the stone.

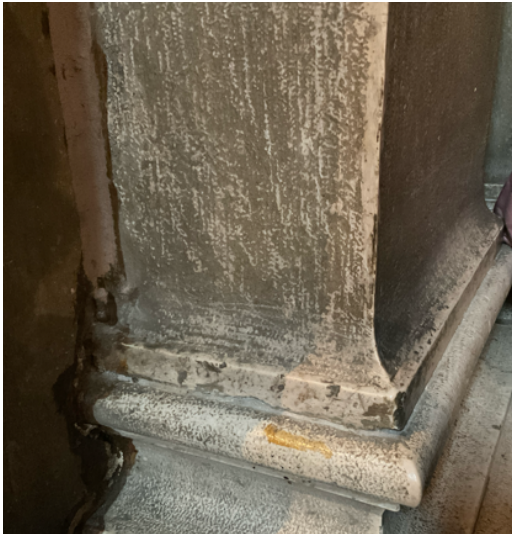
Inside the church, we also examined the accumulation of dust, which had caused the visible darkening of one of the columns.

Dust deposits mainly affect the appearance of the surface, although they may also retain moisture and pollutants. Depending on the condition of the material, dust can be removed using either dry or wet cleaning methods.

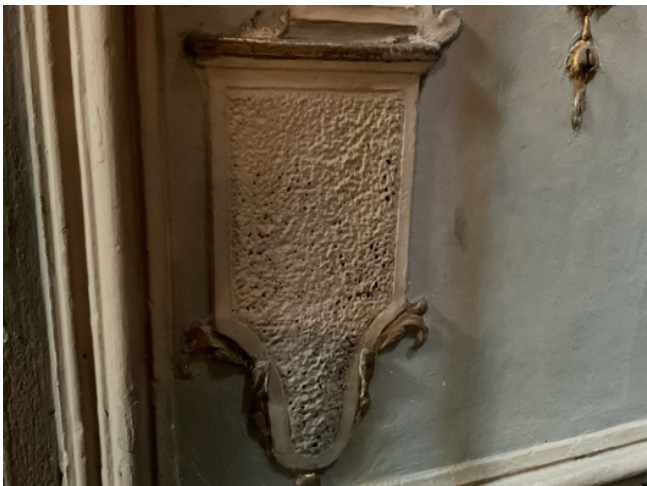
Another phenomenon observed was alveolisation, also known as honeycomb decay. This type of deterioration is characterised by the formation of small cavities or honeycomb-like holes in natural stone.

Alveolisation is often associated with the action of salts, moisture, wind, and repeated cycles of evaporation and crystallisation within the stone.

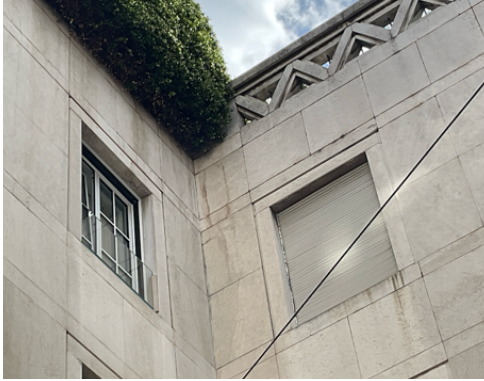
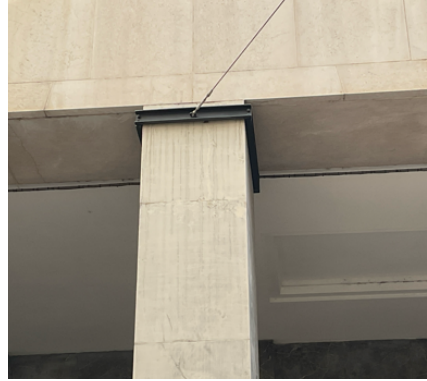
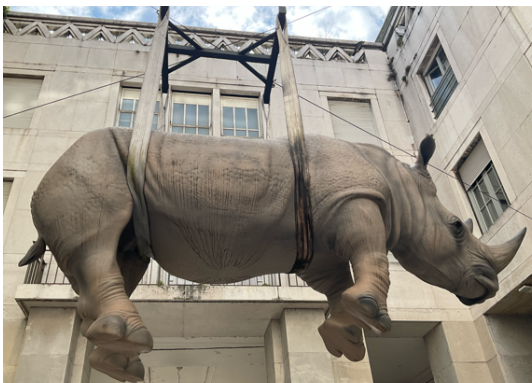
As we continued through the historic centre on our way to Piazza Duomo, we observed several surfaces affected by staining caused by running water.

Flowing water can create dark streaks or stains on façades and stone surfaces because it carries dirt particles, minerals, pollutants, and biological matter along its path. Over time, repeated water flow can make these stains more visible and may also contribute to further surface deterioration.

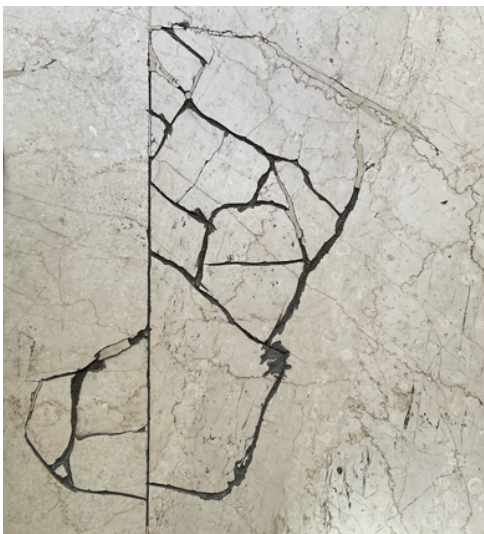
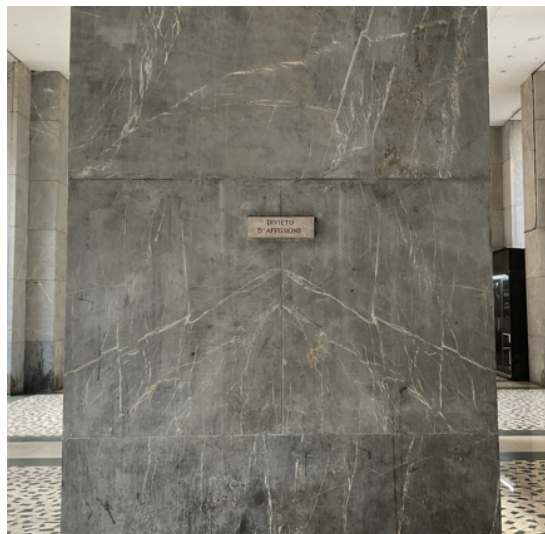
Cracks were another frequently observed phenomenon during our visit. Cracks can develop for a variety of reasons, including structural stress, temperature fluctuations, settlement, mechanical movement, or the presence of moisture.

Their appearance and extent may provide important information about the condition and stability of the building material or structure.

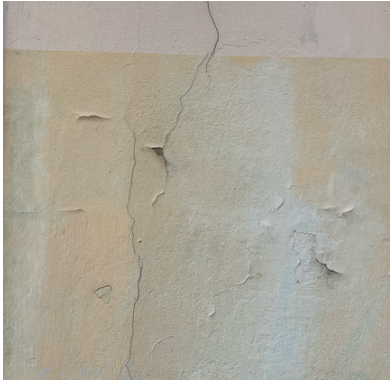
The photograph below illustrates exfoliation on an external wall. Exfoliation occurs when thin layers of material detach from the surface in the form of flakes or scales.

Moisture infiltration and salt contamination are common causes of this phenomenon, as both can weaken the surface layers of the material and eventually lead to their detachment.

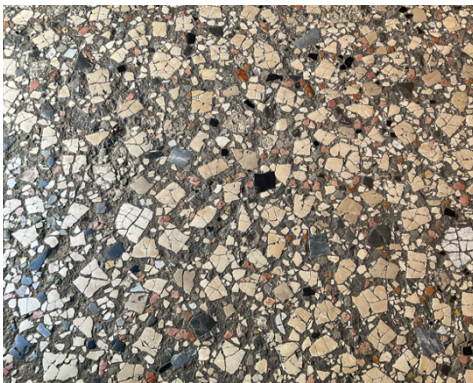
A further example of surface erosion was found inside the Duomo Vecchio. In this case, the erosion was caused by the repeated movement of visitors walking across the stone flooring every day.

Over time, this continuous use gradually wears away the surface of the stone, resulting in a smoother, lowered, and visibly altered walking surface.

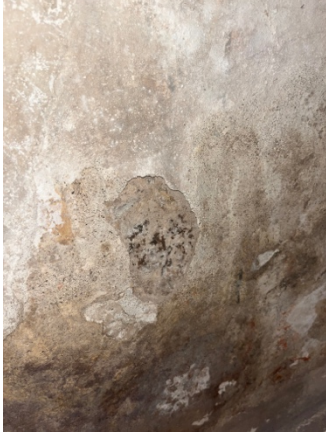
Another degradation phenomenon was detachment. Detachment refers to the separation of a surface layer from the underlying material, even when the detached part has not yet completely fallen away. It may affect plaster, render, mortar, painted layers, or thin sections of stone.

This phenomenon is often caused by moisture infiltration, salt crystallisation, temperature changes, poor adhesion between different materials, or the aging of previous repair layers. Water can penetrate behind the surface and weaken the bond with the substrate. Over time, this may lead to hollow areas, bulging surfaces, cracks, and eventually the complete loss of material.

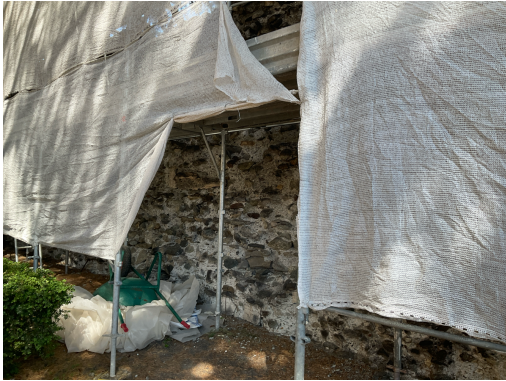
The first stop of the two-day field trip in Aosta was the Roman Wall. This structure was particularly interesting because it showed several conservation problems as well as an ongoing restoration intervention. The work on the wall had started in November, but the intervention had been delayed because official authorization was needed before the restoration process could begin.

At the beginning of the work, the surface of the wall was cleaned with very fine sand, also described as micro-sand. Water was avoided during the cleaning process because the stone could absorb too much moisture. In a cold climate, this would be especially problematic, since absorbed water can freeze, expand and lead to cracks in the stone. Therefore, a dry and controlled cleaning method was chosen. On the scaffolding, the cleaning tools could also be observed, including brushes, small saws, pliers and trowels. Red, very fine sand was used for the cleaning of the masonry surface.

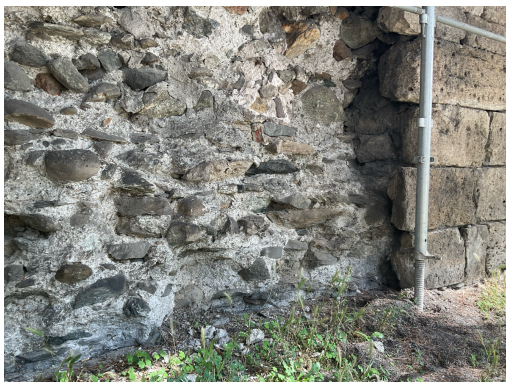
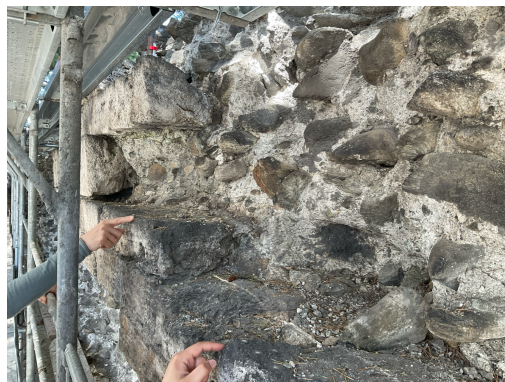
The wall construction was also discussed in relation to its internal and external structure. The inner part of the wall is called “sacco”, which refers to the internal rubble core of the masonry. This core gives mass to the wall and connects the two external faces. The outer visible part of the wall consists of travertine stones, called “travertino”. These stones form the external masonry surface and protect the inner core. In some areas, the travertine stones become narrower towards the top and were arranged in a way that created a stronger connection with the sacco. This connection between the external stone faces and the internal core is important for the stability of the whole wall.

The stone arrangement was also partly described as similar to a herringbone pattern. The masonry showed irregular openings or gaps between stones, which are typical for this kind of historical wall construction and may have been intentional in some parts. The wall was therefore not only analysed as a damaged structure, but also as an example of historical construction technique.

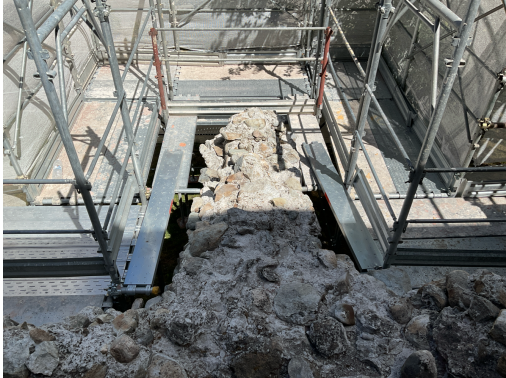
Another structural element mentioned during the visit was the use of a “Contraforte”. A “Contraforte”, or buttress-like reinforcement, is used to support and stabilize a wall. It helps resist lateral forces and prevents the masonry from moving or collapsing outward. This was especially relevant because the Roman Wall had already required structural stabilization in the past. In 1920, an intervention had already been carried out to prevent the wall from falling.

The wall also showed black crust, especially visible from the scaffolding. Black crust usually forms on stone surfaces exposed to air pollution and moisture. It creates dark deposits on the surface and can accelerate degradation, especially when it traps pollutants and moisture close to the stone.

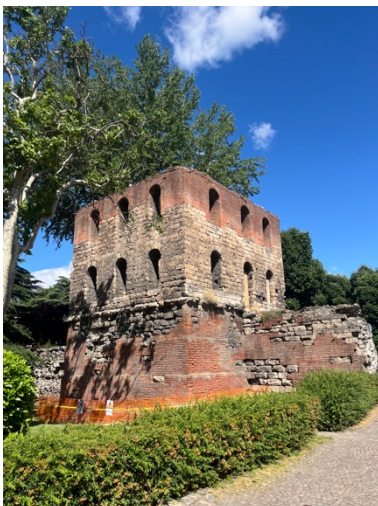
The mortar was another important aspect of the analysis. It consists mainly of water, sand and lime. Laboratory analysis can help identify the composition of the mortar and recognize specific degradation phenomena. This is important because compatible repair materials must be chosen carefully. In this restoration, the wall was repaired with stones similar to the original ones. This differs from the restoration of the Tour de Pailleron, where other stones had been used.

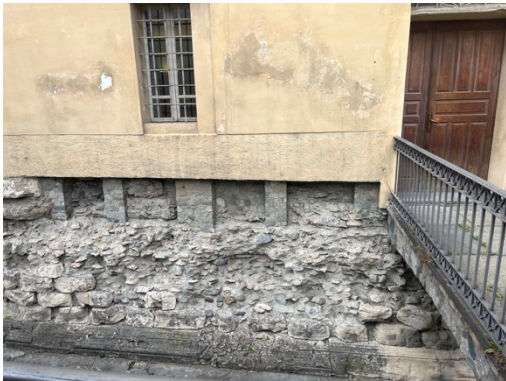
One interesting aspect during the visit was the difference between the Roman level and the present level of the city. The Roman level was much deeper, with a change of approximately 2.5 metres. This showed how much the urban level changed over time and how the ancient structures are now partly below the modern city.

Inside the museum, different structural and restoration aspects were discussed. We saw one pillar where it was explained that, during an earthquake, the pillar could move. For this reason, it can be better to connect the pillar with the upper part of the structure in order to create a safer structural connection.

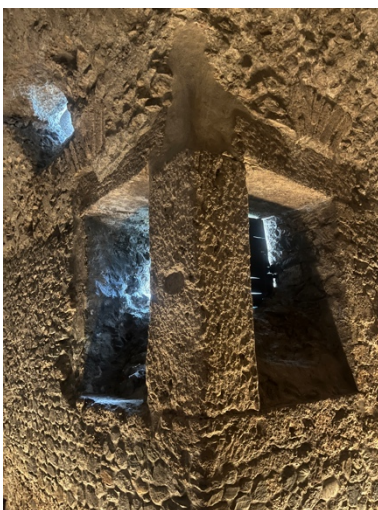
It was also explained that during the medieval period the Criptoportico was used in a different way, almost like a cave. Some former entrances or openings are still visible today. In the wall,

divided holes or separated openings could be recognised, which show later transformations of the ancient structure.

Another topic was the visibility of restoration processes. In some areas, openings in the wall had been closed during restoration. Different textures and different blocks were used so that the restored parts can be recognised and distinguished from the original material. This approach makes the restoration process visible instead of hiding it completely. It also raises the question of how integrity should be understood in restoration.

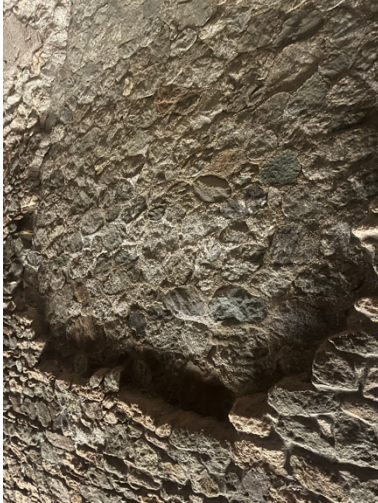
Another restoration solution was the addition of pillars to support a specific part of the structure. Through this intervention, the internal core, or sacco, remains visible. This showed that support can be added without completely covering the historical construction. (5)

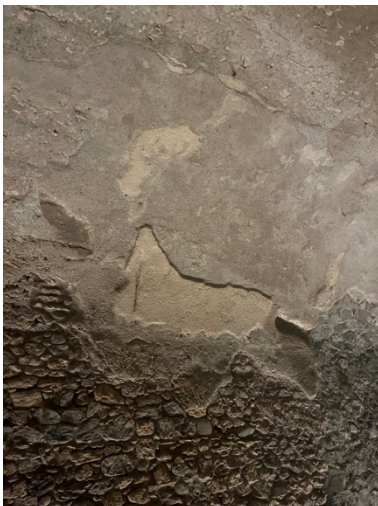
In another area, we saw a different support. This support carried a high load, so it did not need to be connected to the part above in the same way. The explanation was that the support was already strongly compressed by the weight above.

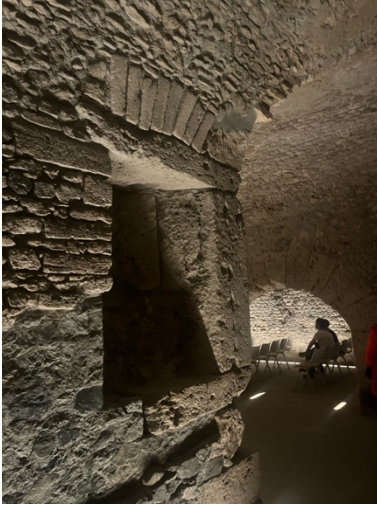
In another part of the visit, we could see a pillar that had been tied or strapped in order to improve its stability. This intervention was used to secure the pillar and prevent further movement or damage.

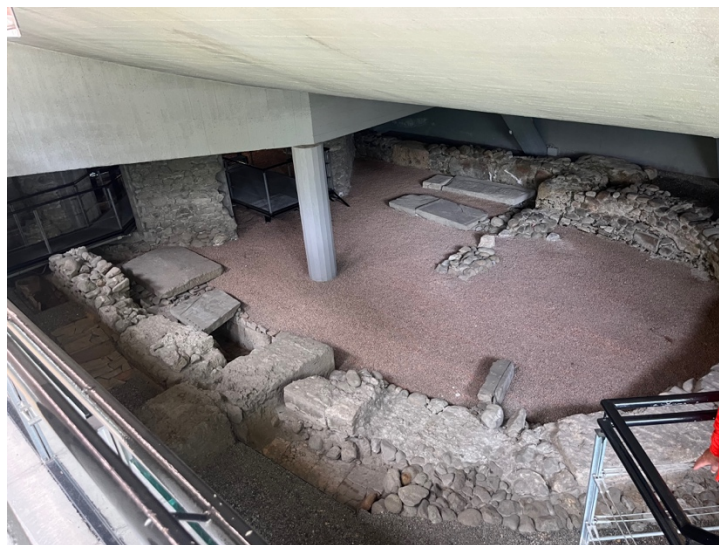
The early building had a Latin-cross plan and was about 36 metres long and 32.5 metres wide. It had apses on the east-west axis and a liturgical area with a semi-circular bench, the synthronon, in front of the apse. In the centre of the church there was a solea, a liturgical passage surrounded by a stone balustrade. The sarcophagus of bishop Agnellus, who died in 528, was found beside this enclosure.

Many tombs were discovered under the whole surface of the church. Large masonry tombs, called formae, were covered with marble slabs and also served as pavement. Burials continued until the middle of the 8th century, when the building was destroyed by a major fire. Later, the site was also affected by flooding from the Buthier river, which left alluvial layers over the remains.

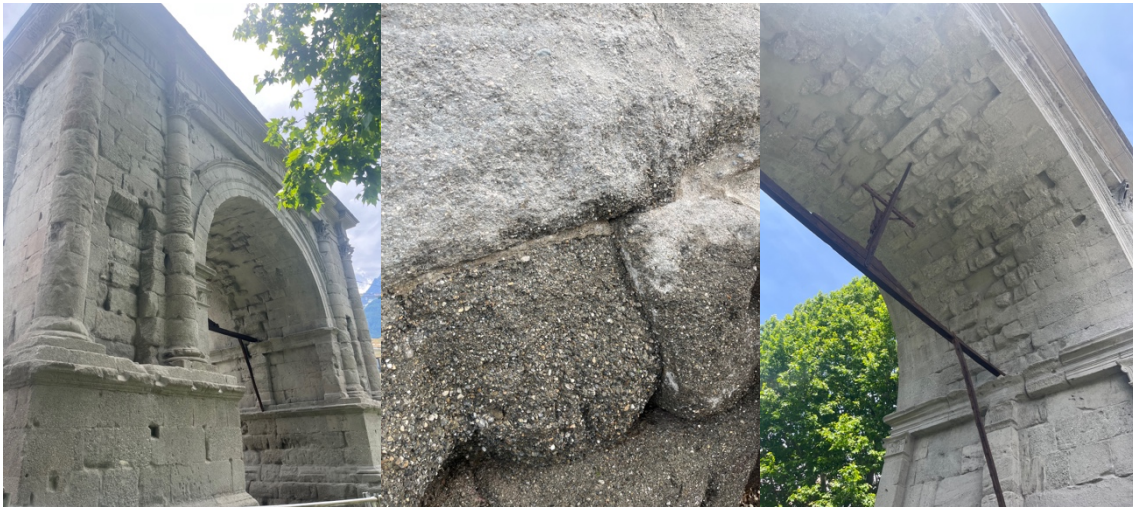
A main topic was the effect of wind on the monument. Because the wind can come from two different directions and passes through the reduced opening of the arch, its speed increases. This stronger air movement can intensify erosion on the stone surfaces. The impact of wind is not the same everywhere, because the angle of exposure changes depending on the position on the arch.

Humidity also plays an important role. Together with carbonic acid, it can affect the stone material and contribute to decay. In some areas, the stone can become hollow inside. This can be detected by knocking on the stone: a hollow sound indicates that the internal structure is damaged or detached. In such cases, the hollow areas can be filled with mortar to stabilise the stone again.

Rainwater was another important factor. Water entering from above damages especially the stones in the middle part of the arch. During winter, water and ice can accumulate in this area. When the water freezes, it expands and creates pressure inside cracks and pores. This process can lead to spalling and the detachment of stone fragments.
