# REPORT

# ARCHITECTURAL RESTORATION AND CONSERVATION

LECTURER: Prof.ssa Barbara Scala

STUDENT: Philipp Schönfeld

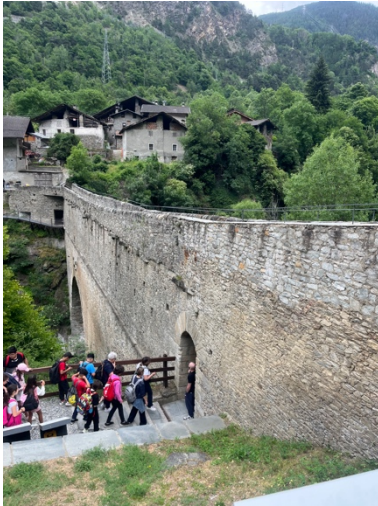
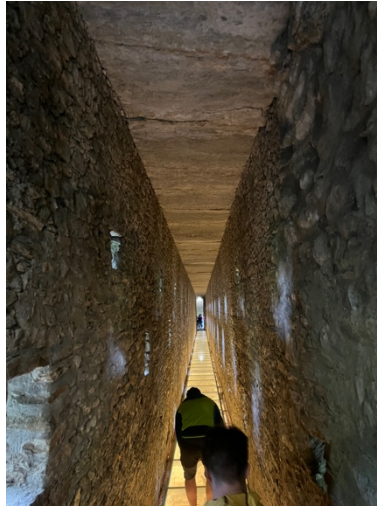
As the last stop, we visited Pont-d'Ael in the village of Pondel/Aymavilles. It is a Roman aqueduct bridge from the Augustan period and was built above the Grand Eyvia stream. The bridge had two functions: the upper part worked as a water conduit, while the lower part could be used as a passage for people and animals. The monument was later restored and made accessible for visitors as part of a conservation and valorisation project.

During the visit, we discussed the construction and the different types of stone used in the bridge. The internal passage is divided by several transverse masonry walls, which create hollow chambers. This construction made the bridge stable, but also reduced the amount of material needed. We also looked at the connection between the two bridge walls. In some areas, the connectors were directly linked with the walls, and cracks were visible. In other areas, they acted more like intermediate pieces, where no cracks could be seen. This showed that different structural solutions can behave differently over time.

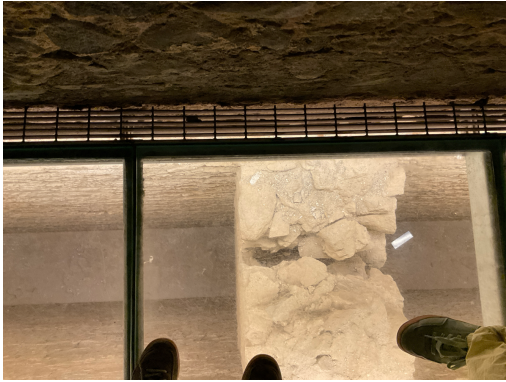
Another important point was the modern glass walkway inside the bridge. It was mainly added for visual and didactic reasons, because it allows visitors to see the internal structure of the monument. However, this solution also creates conservation challenges: constant ventilation is necessary, otherwise humidity could become a problem inside the enclosed space.

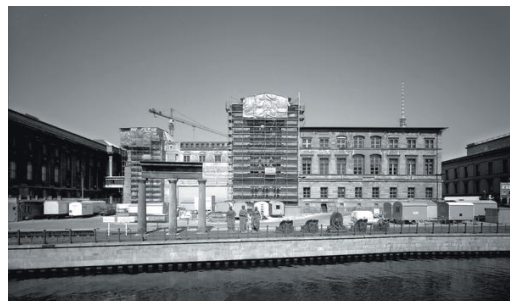
- Built between **1843–1855**
- Architect: **Friedrich August Stüler**
- Commissioned by **Frederick William IV of Prussia**
- Located on **Museum Island** in Berlin
- Designed to house **Egyptian and archaeological collections**
- Severely damaged during **World War II**
- Remained a **ruin for several decades after the war**
- Restoration project started in the **late 1990s**
- Museum Island designated **UNESCO World Heritage Site** in 1999

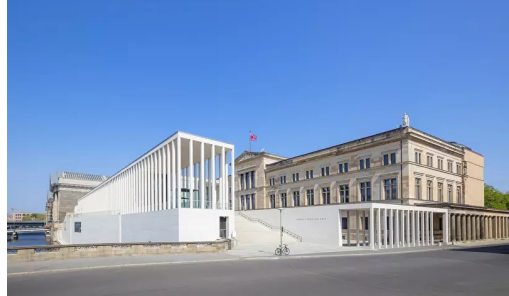
- **Architects**
  - David Chipperfield
  - Julian Harrap
- **Main Principles**
  - **Preservation of the remaining historic fabric** and original fragments
  - **War damage intentionally preserved** as part of the building's history
  - **Minimal intervention** to protect authenticity
  - **Clear distinction between historic and new elements**
  - Missing structures reconstructed using **contemporary architectural design**
- **Materials and Construction**
  - Use of modern materials such as **concrete, brick, and steel**
  - New elements designed to **complement but not imitate** the original architecture
- **Conservation Framework**
  - Approach based on principles of the **Venice Charter**
  - Aim: maintain **authenticity, legibility of historical layers, and functional reuse**

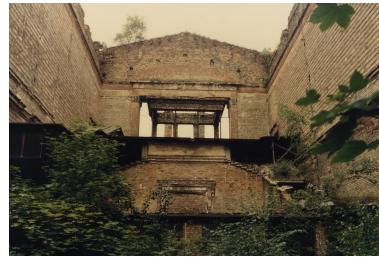
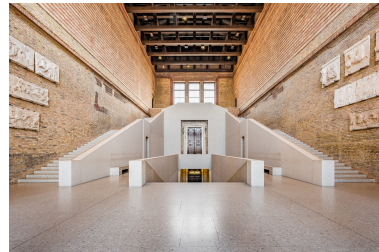
- **Neues Treppenhaus**
  - Original staircase **completely destroyed during World War II**
  - **Reconstruction of the original spatial geometry**
  - **Contemporary interpretation** of the historic form
  - **Minimalist design** without historicist decoration
  - Makes the **historic spatial structure legible** without creating *"fake history"*
- **Egyptian Courtyard and Galleries**
  - **Fragments of wall paintings carefully conserved**
  - Missing areas **completed with neutral materials**
  - **Original brickwork intentionally left visible**
  - Restoration reveals the **different historical layers of the building**

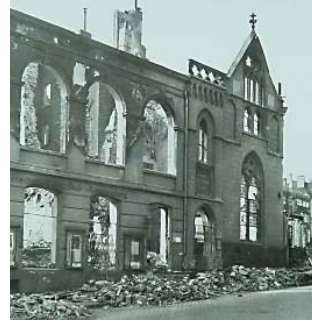
- Located in **Cologne**, Germany
- Built on the ruins of the medieval **St. Kolumba Church**
- The church was destroyed during **World War II**
- The ruins and archaeological remains were **preserved on the site**
- In 1949 a small chapel, **Madonna in den Trümmern Chapel**, was built within the ruins
- Archaeological excavations revealed **Roman, medieval, and modern remains**
- The site therefore contains **multiple historical layers spanning nearly 2000 years**
